# Northridge Earthquake Failure

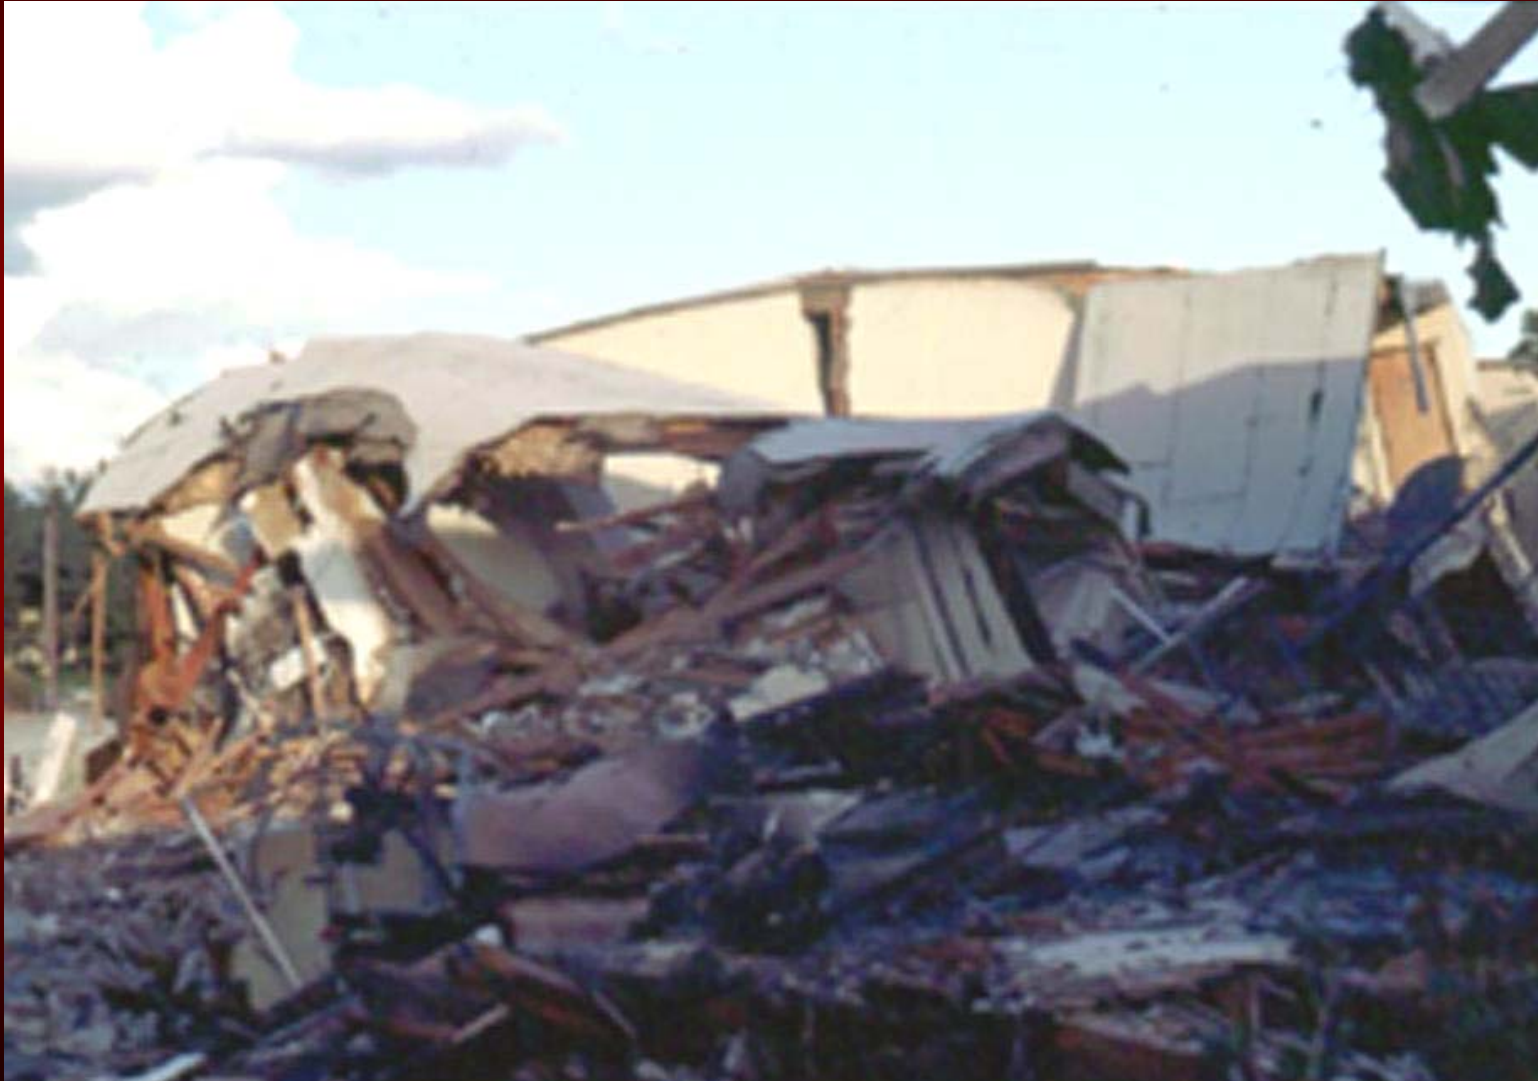
Total collapse

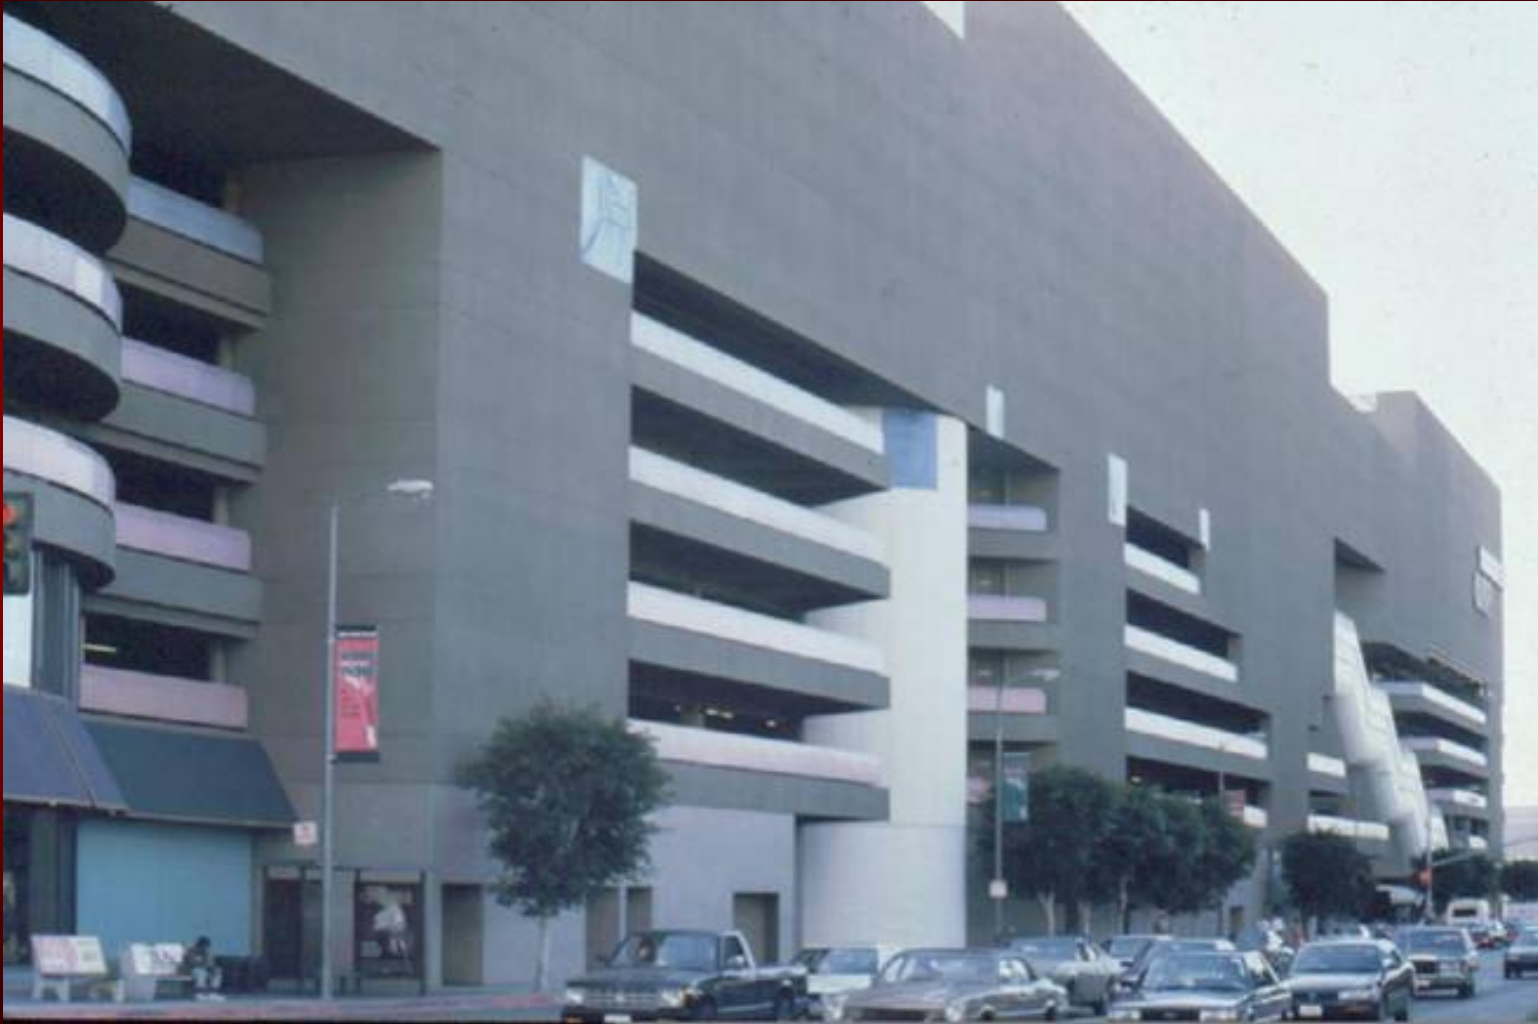
# Cosmetic damage

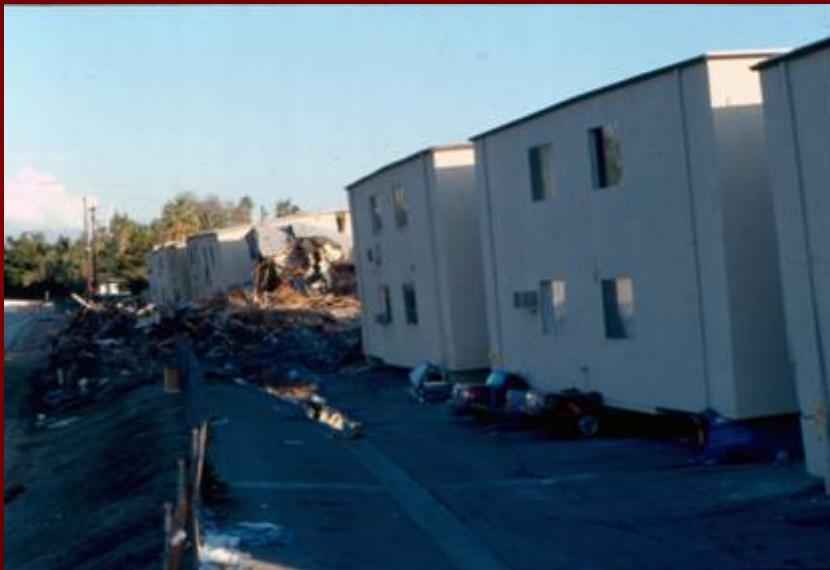
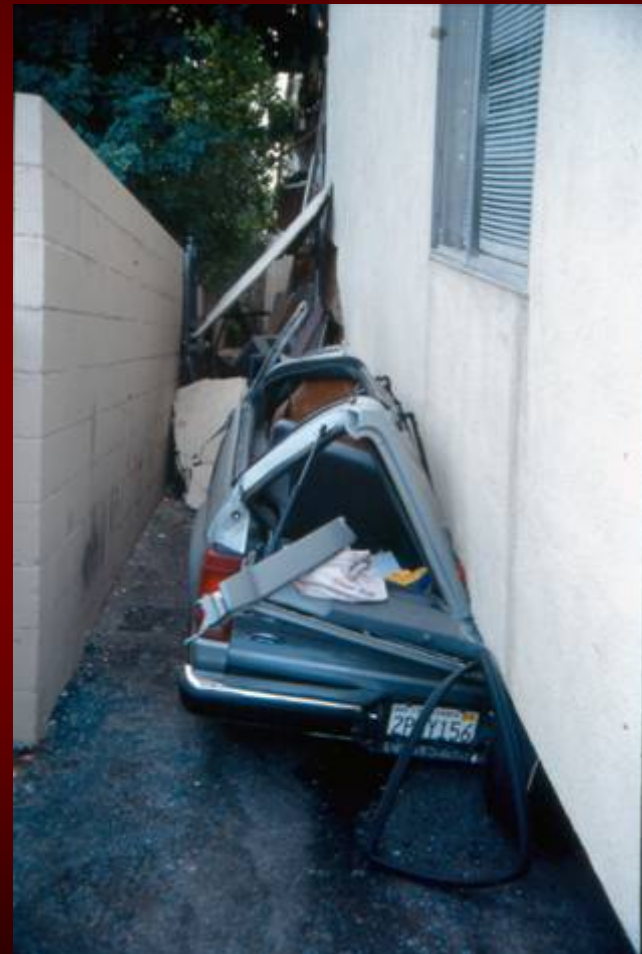
# Soft-story collapse

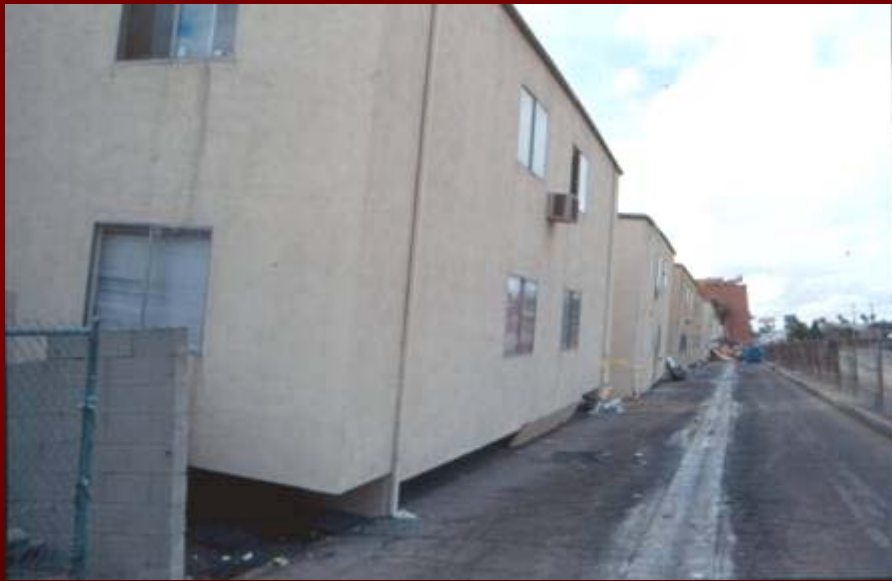
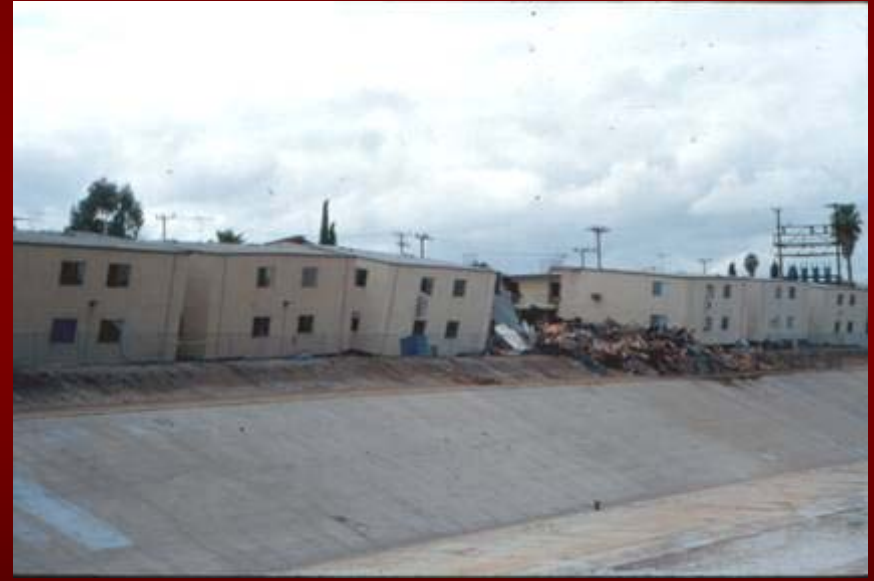
# Soft-story collapse

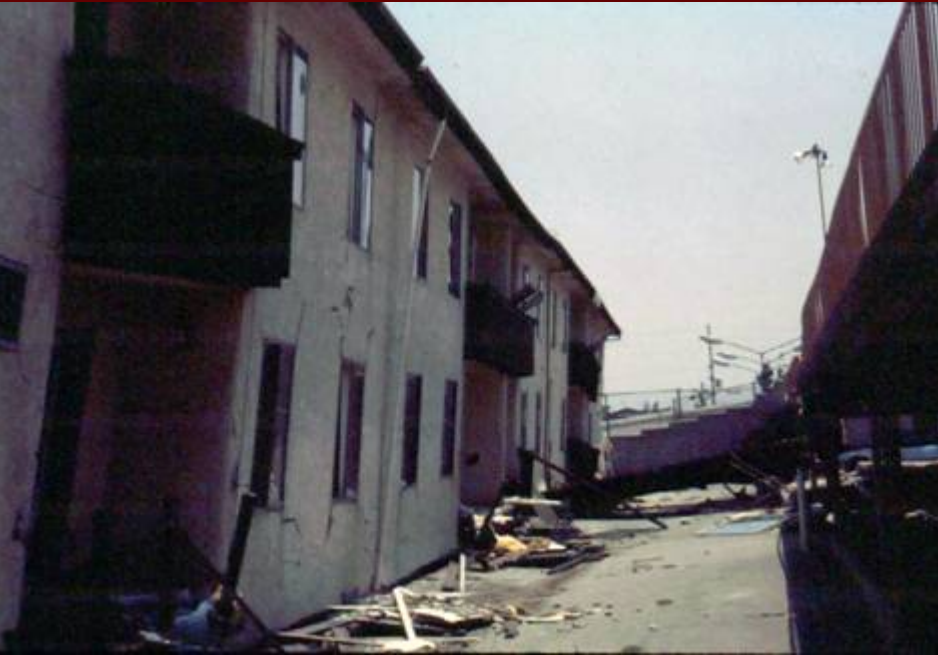
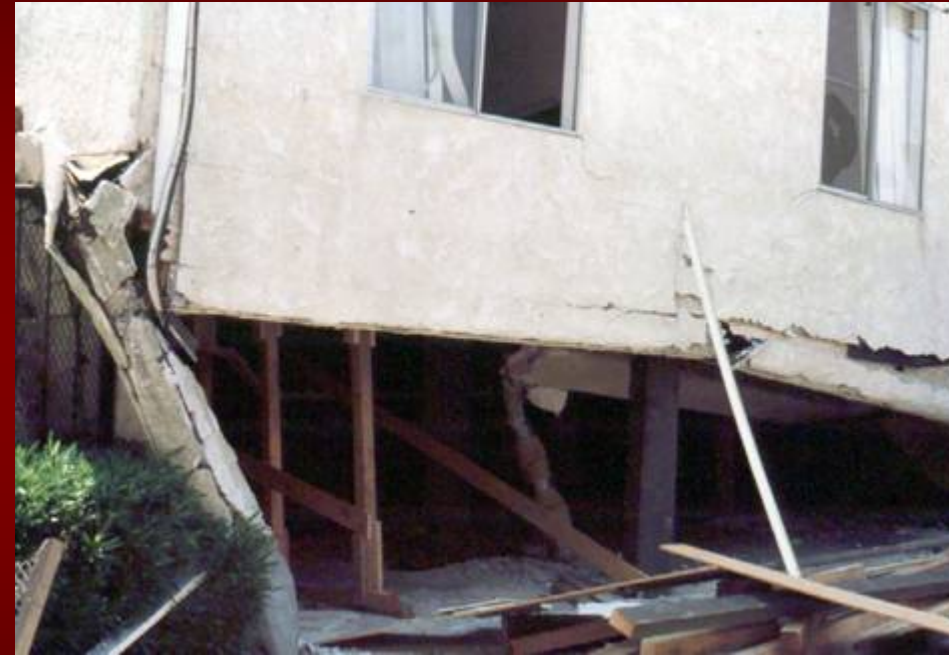
# Soft-story collapse

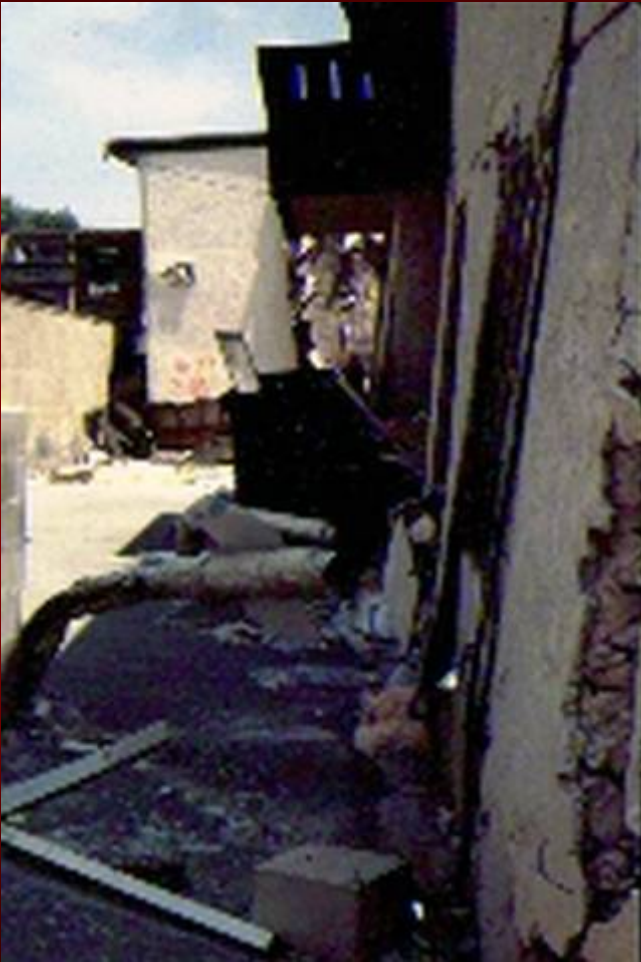
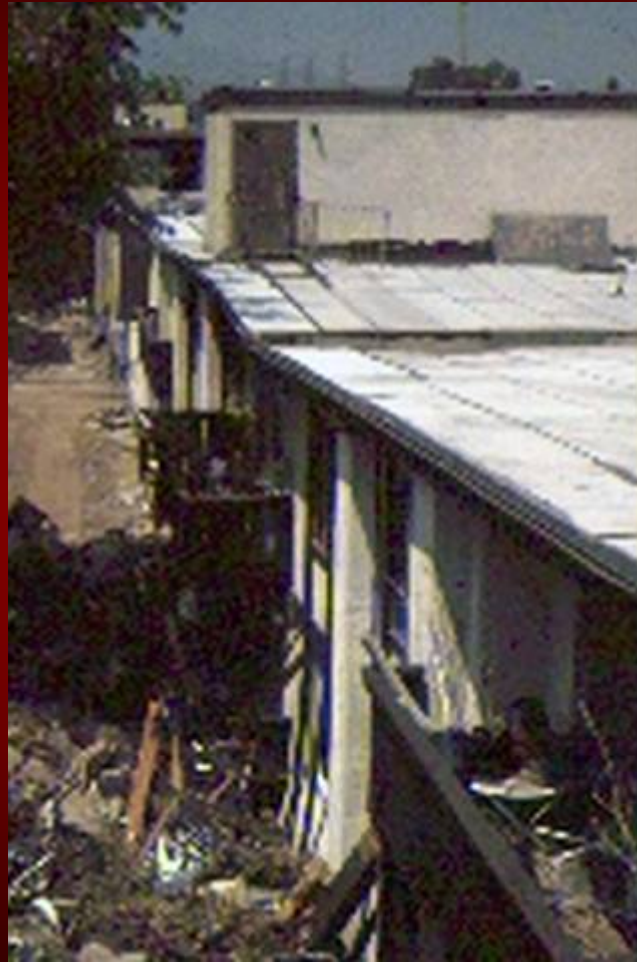
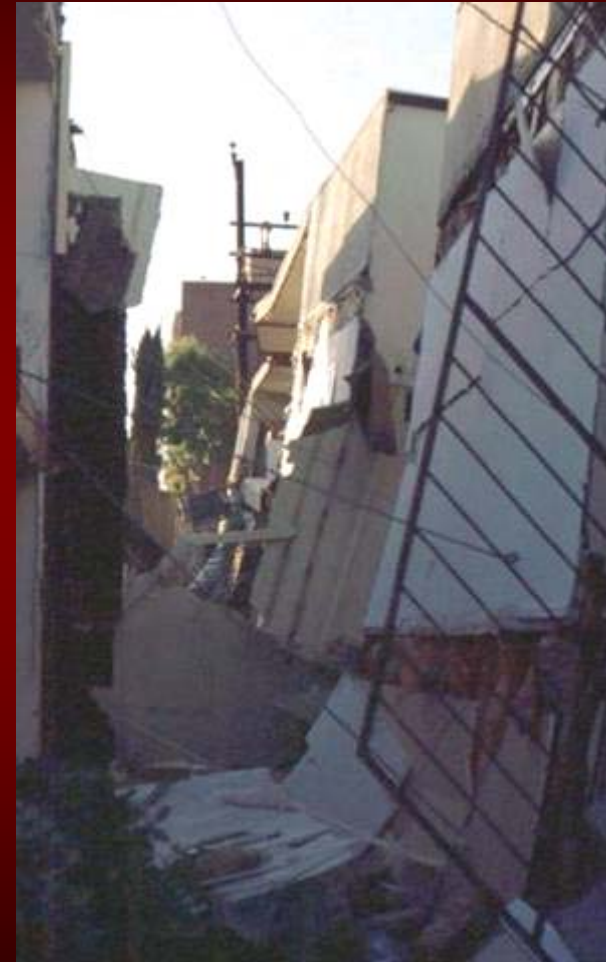
# Soft-story collapse

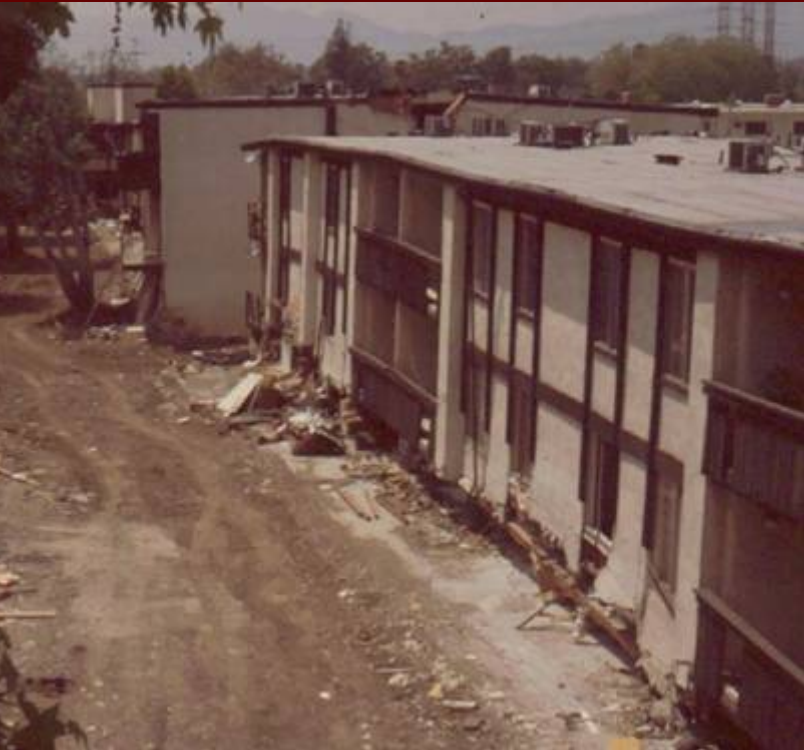
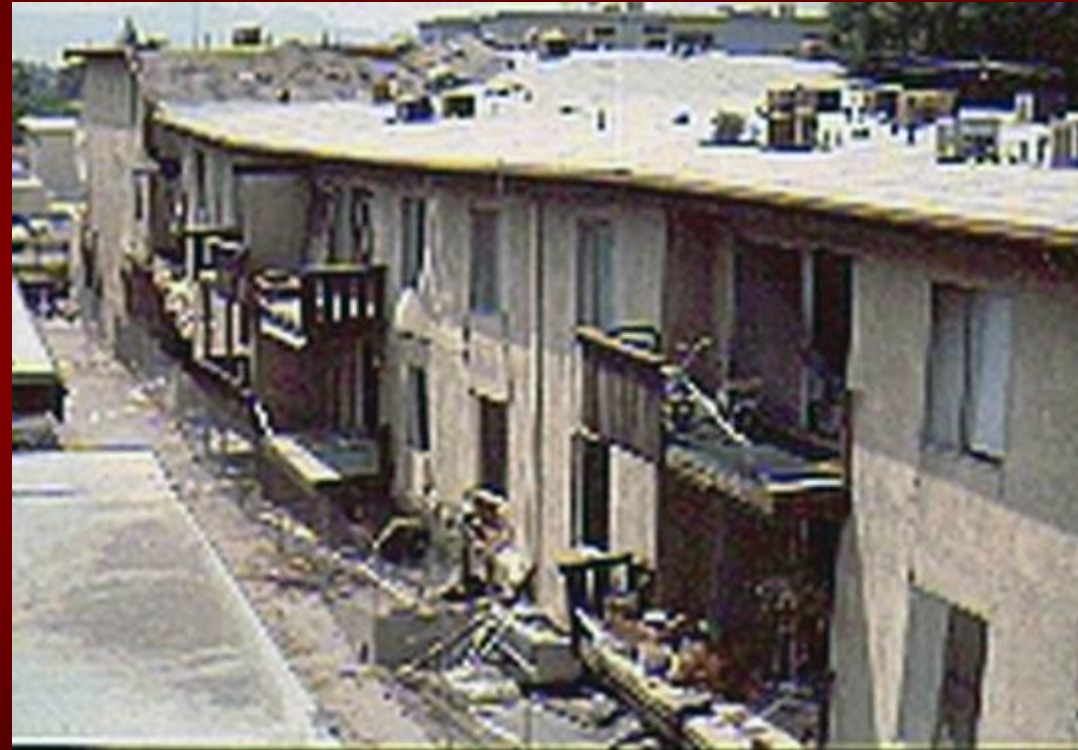
# Soft-story collapse

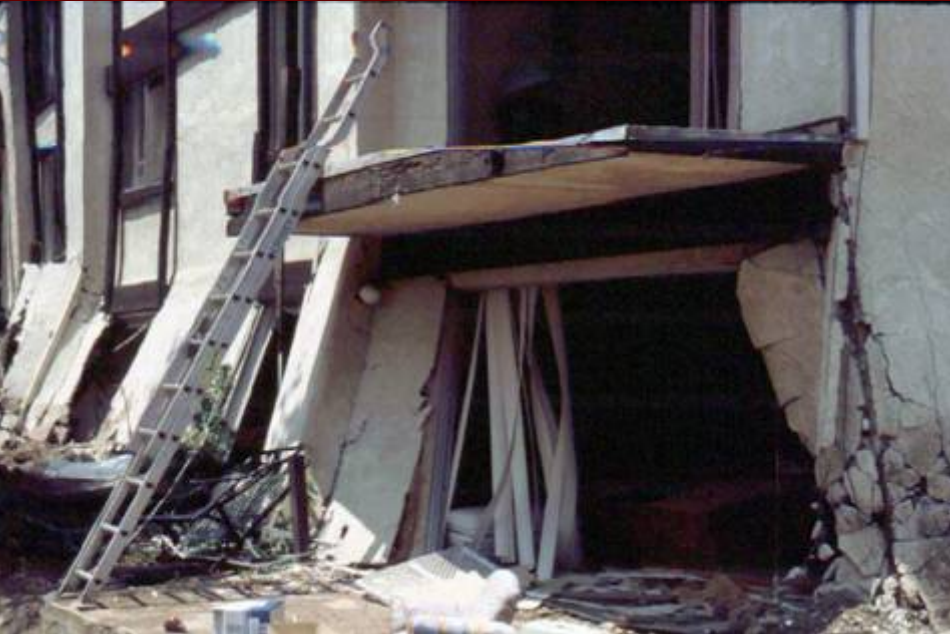
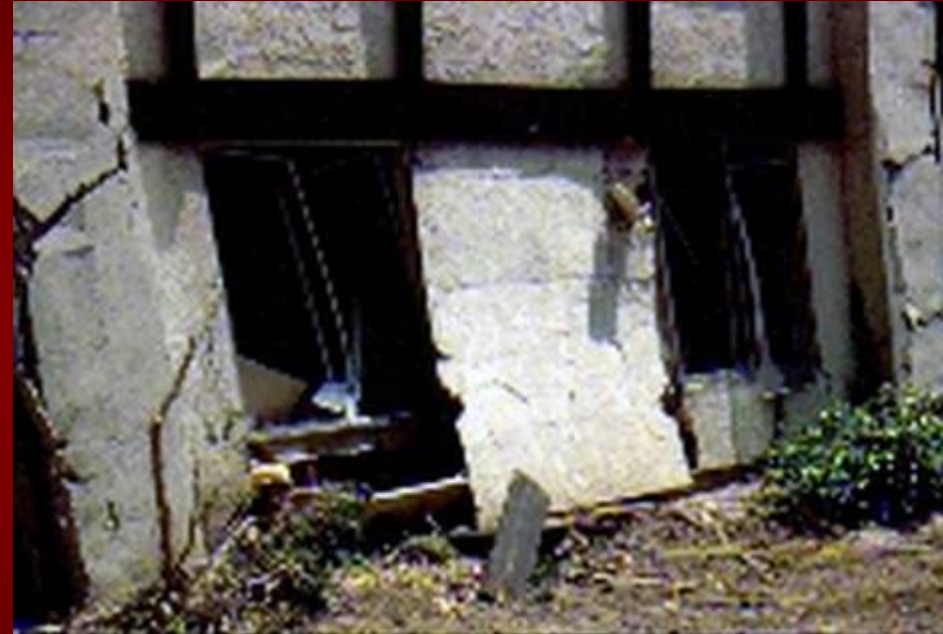
# Soft-story collapse

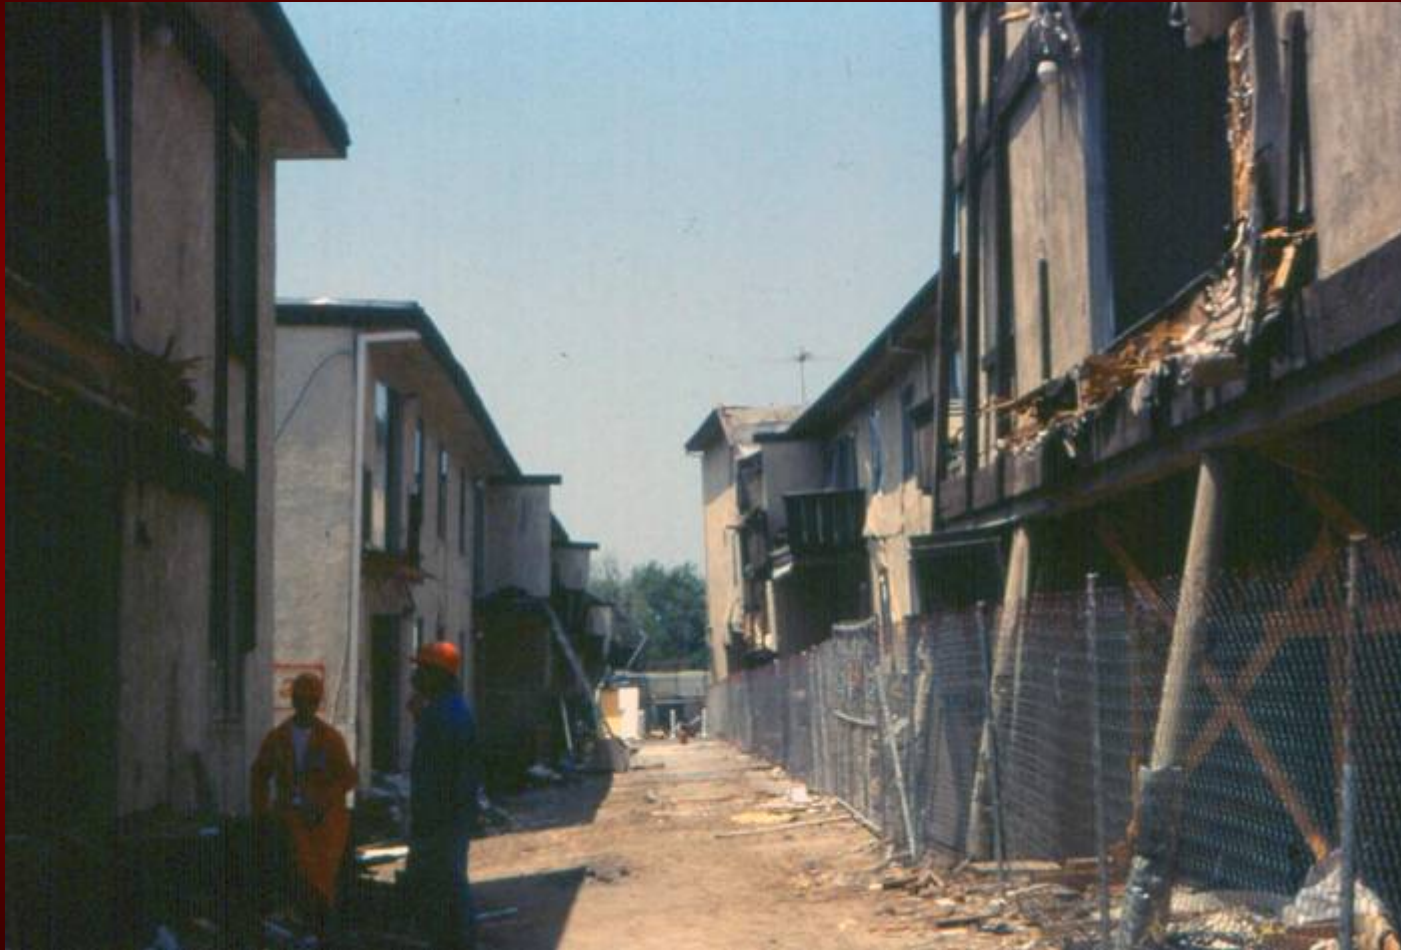
# Almost soft-story collapse

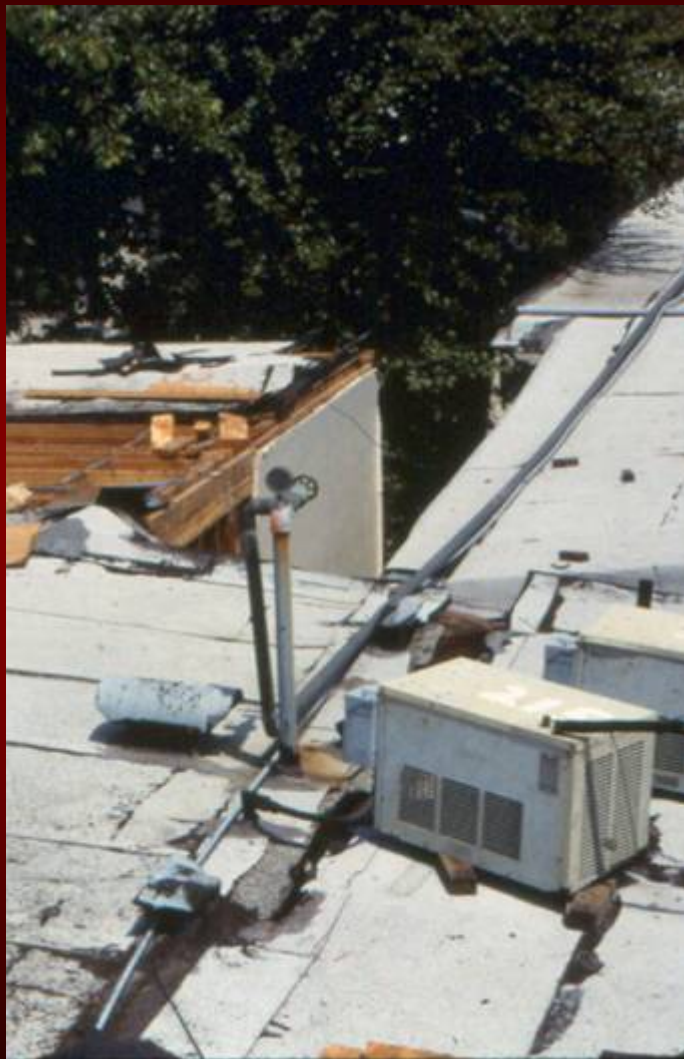
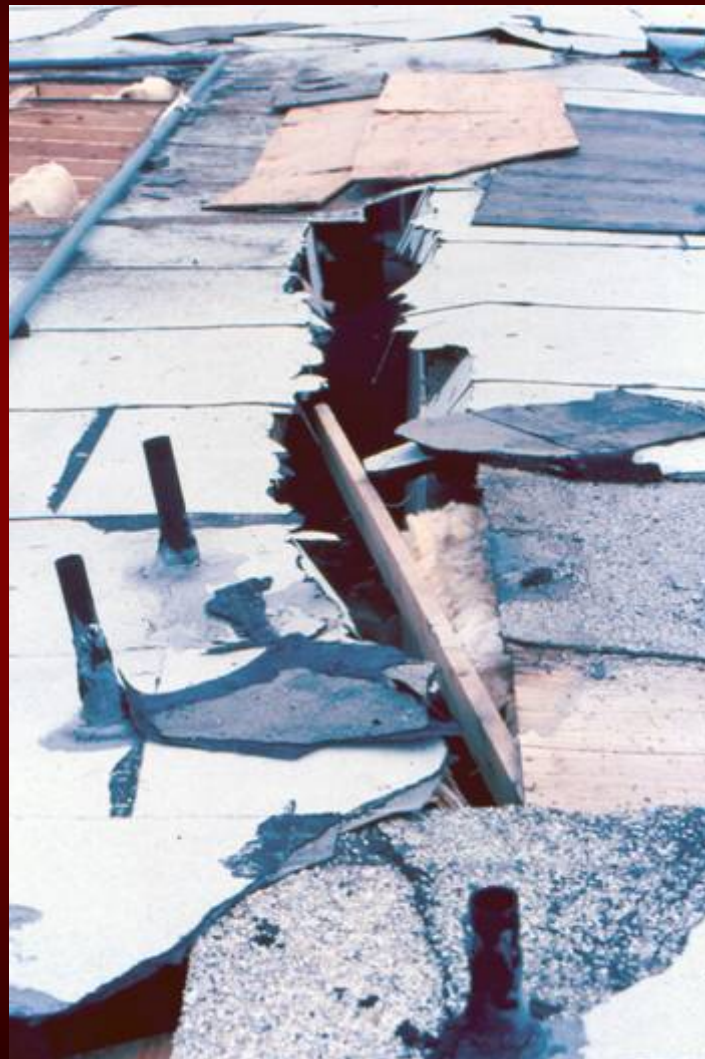
# Hazard configurations: wings split at intersections

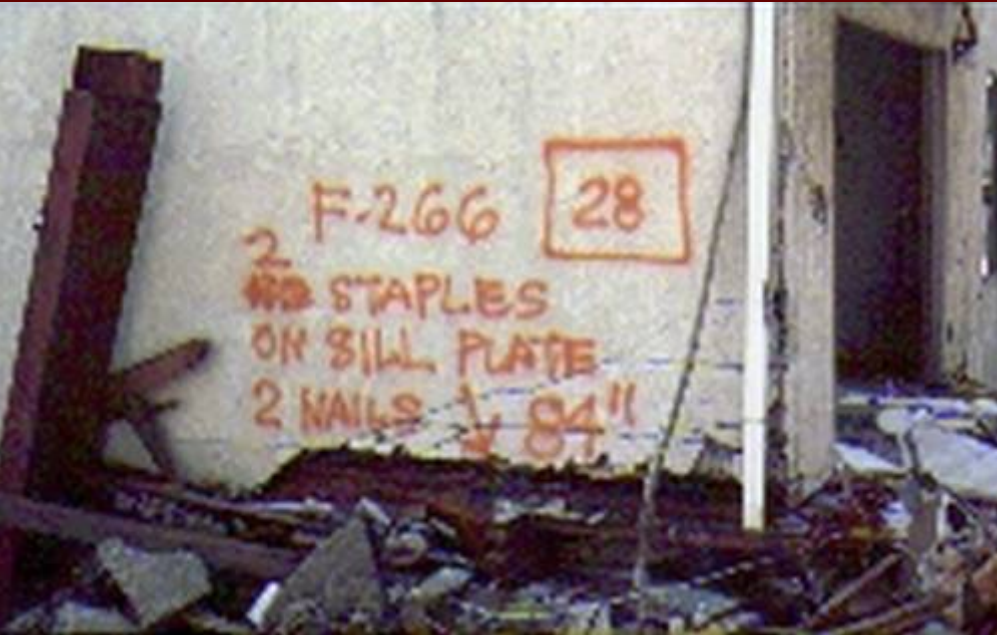
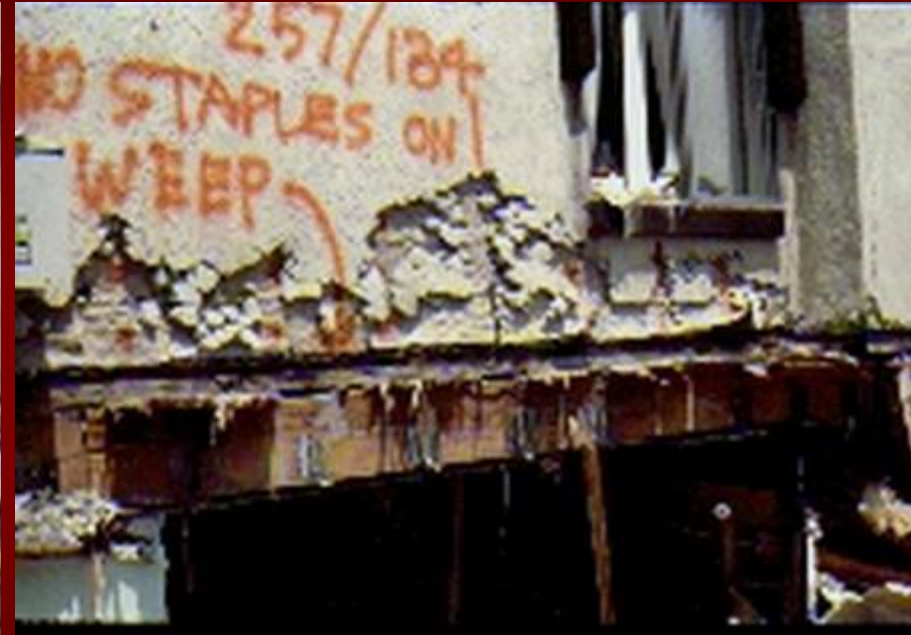
# Flawed construction quality

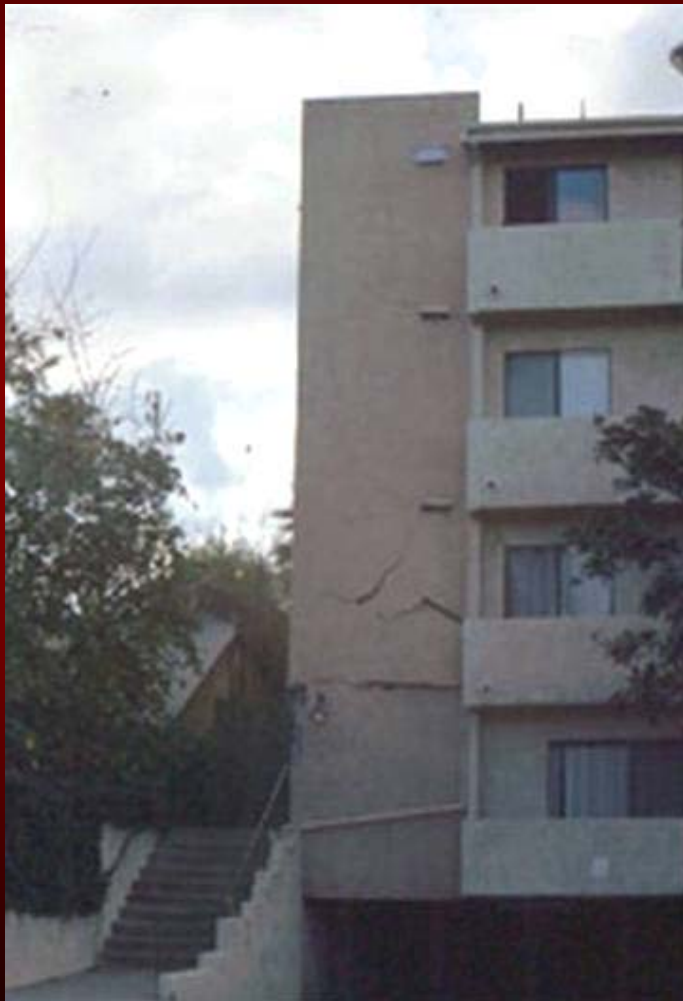
## Slender shear wall failure

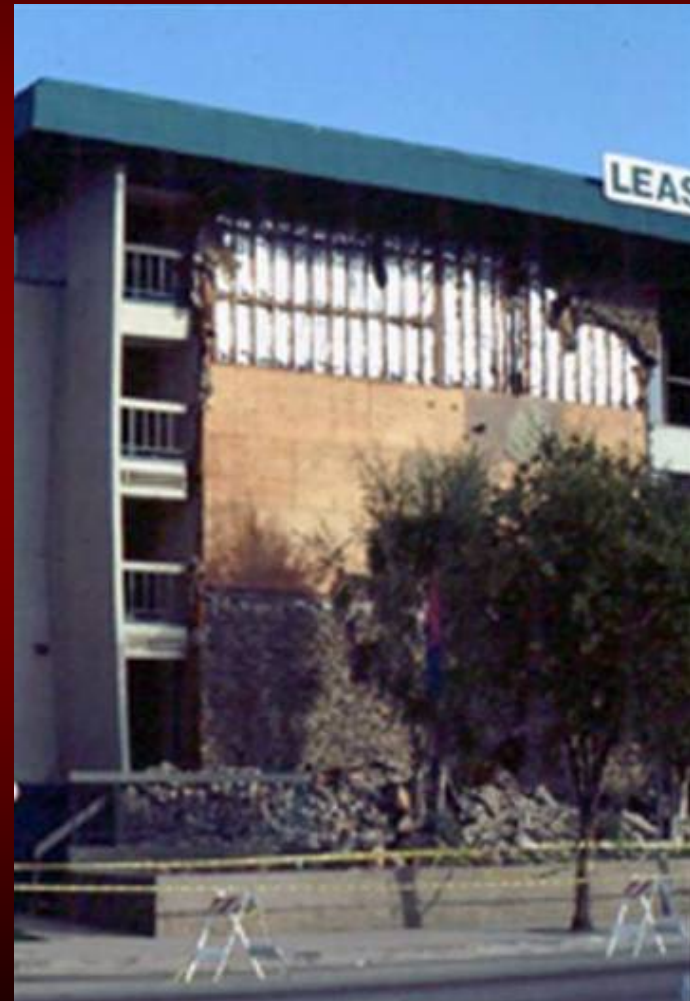
## Brick veneer failure (avoid brick veneer on tall wood walls)

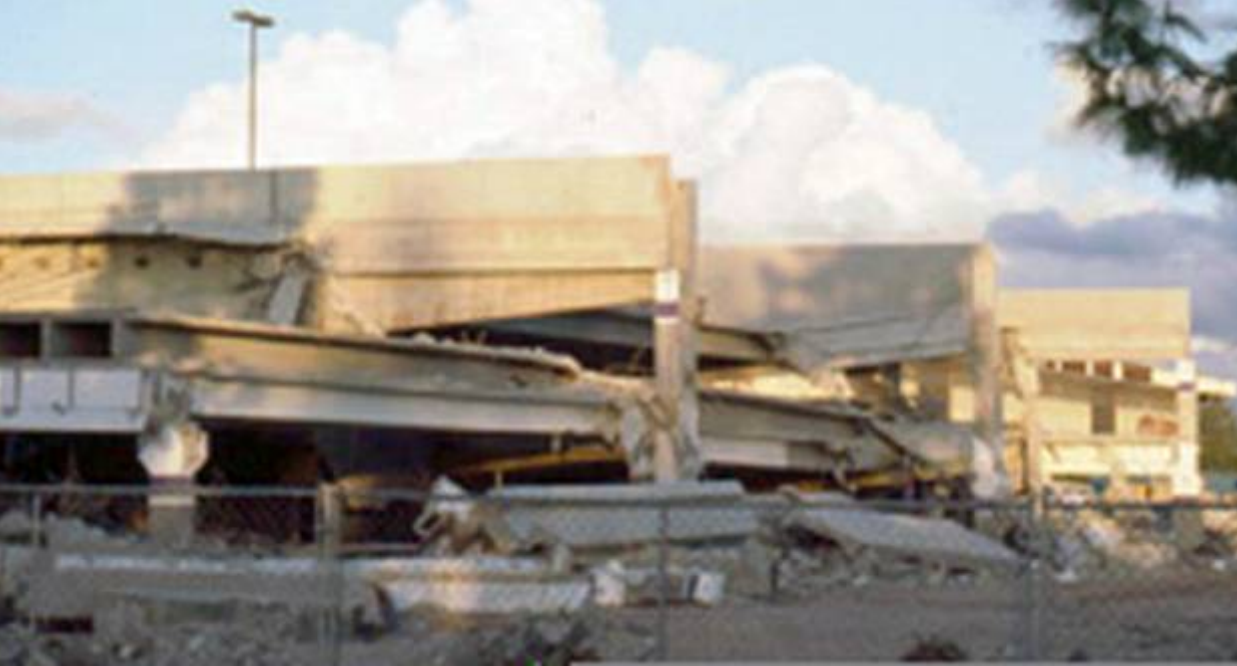
## Prefab parking garage

- Collapse

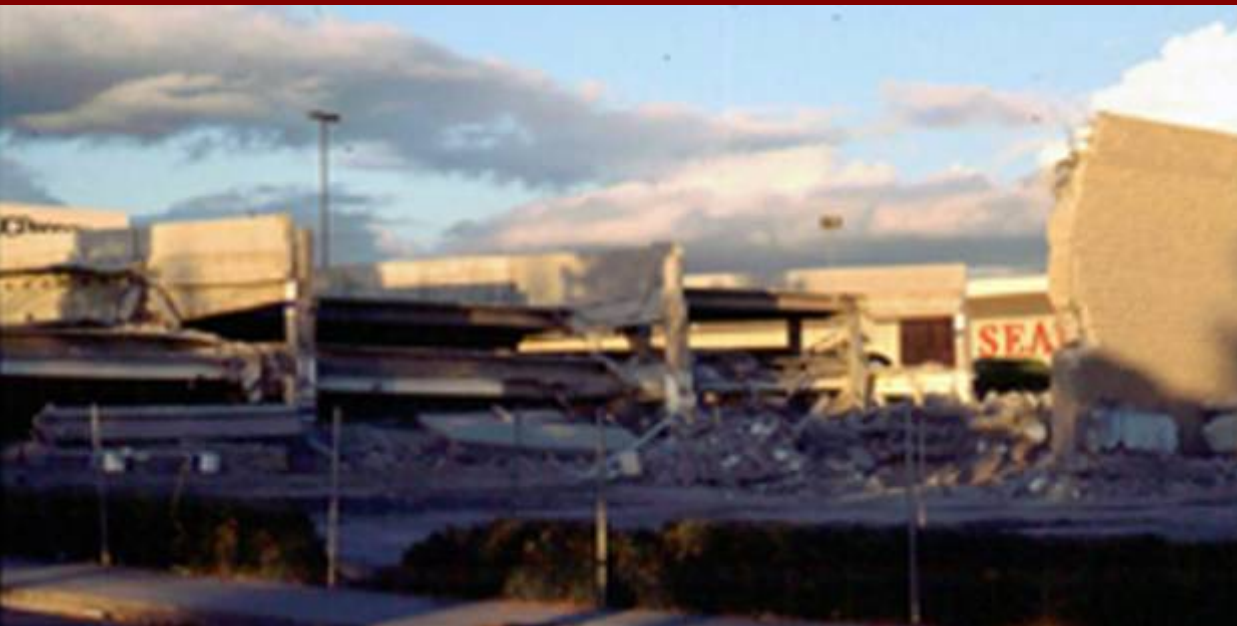
- CMU wall failure

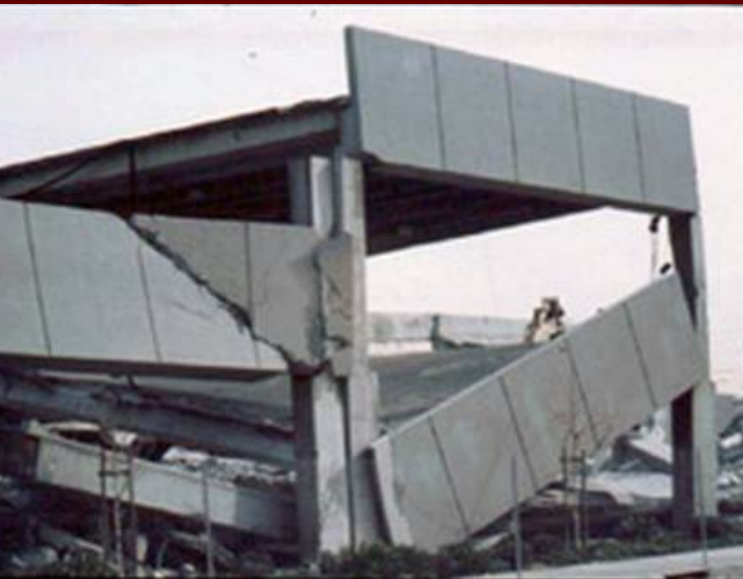
Prefab parking garage  
parapet failure

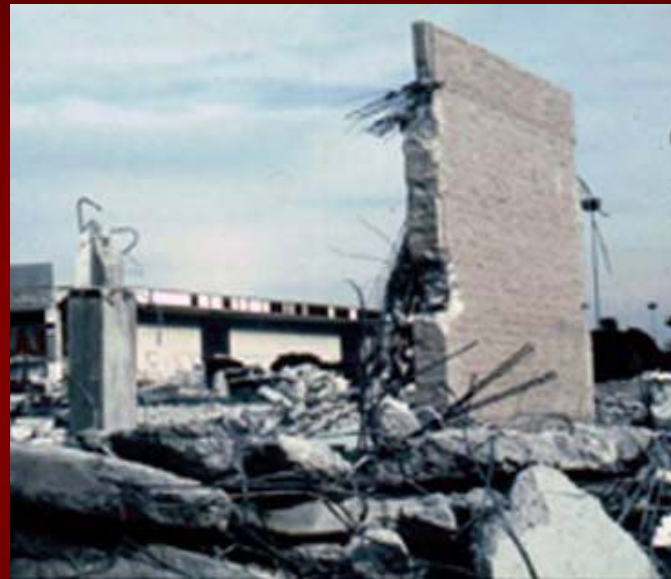
wall failure

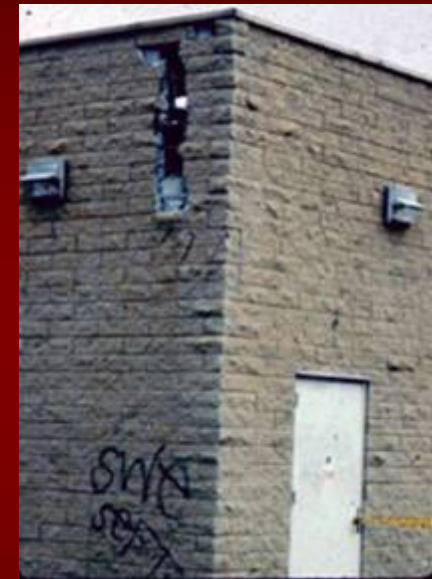
wall cracks

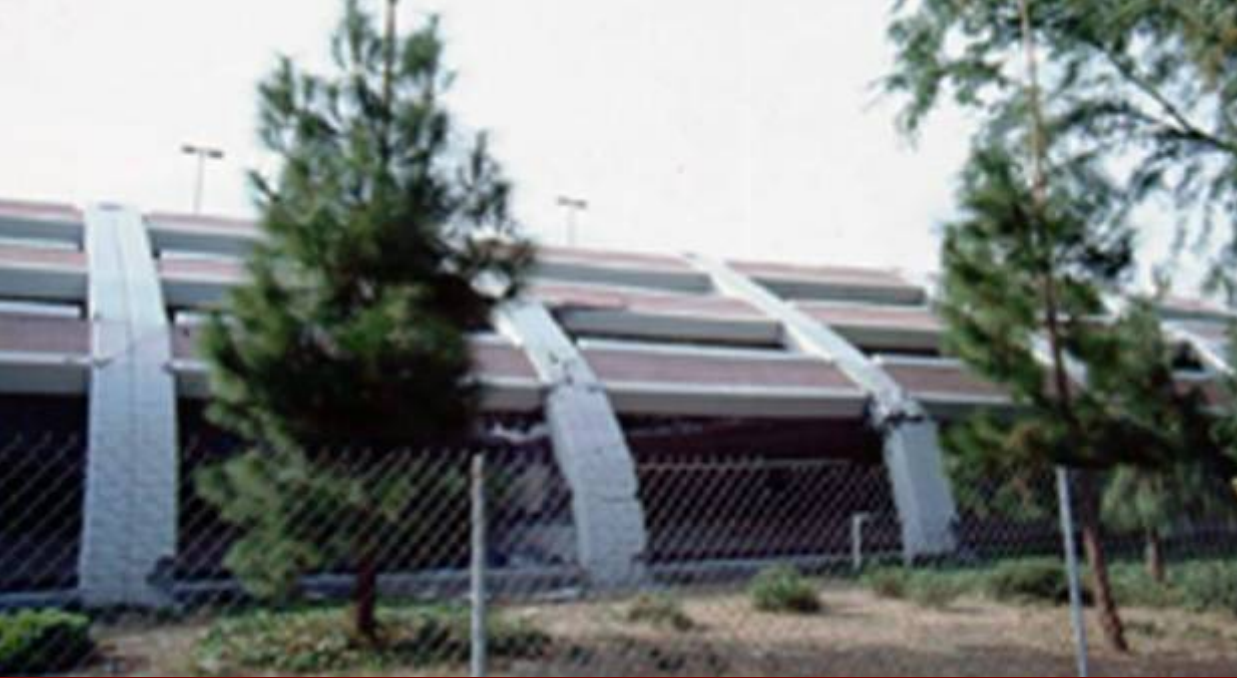
## Parking garage

- Wall pulled over by concrete slabs

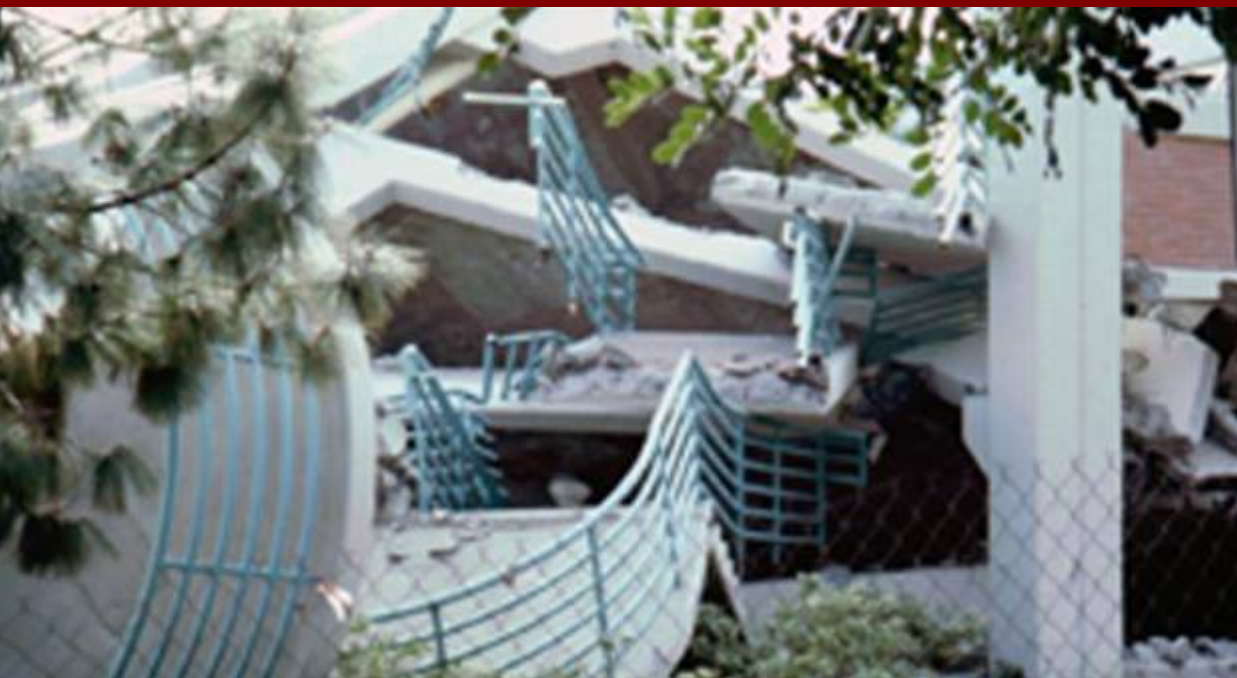
- Exit stair collapse

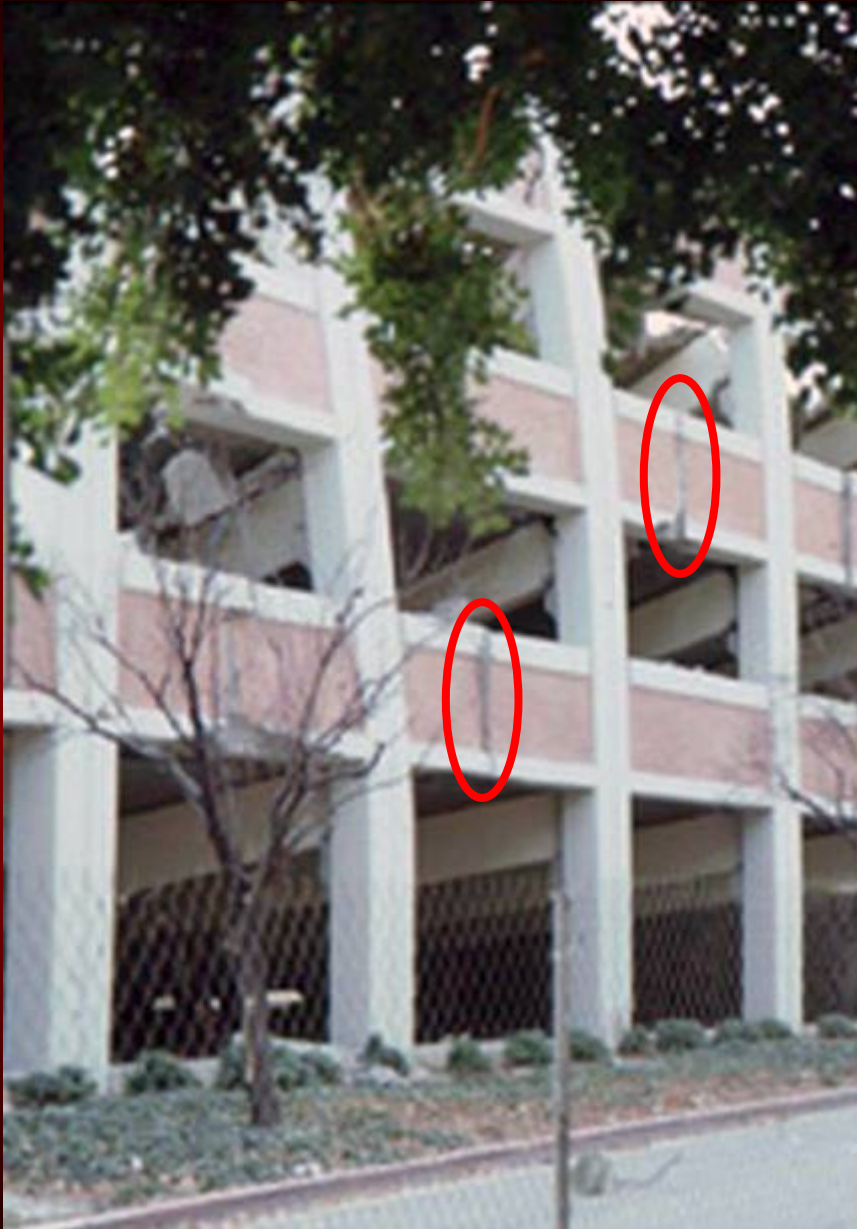
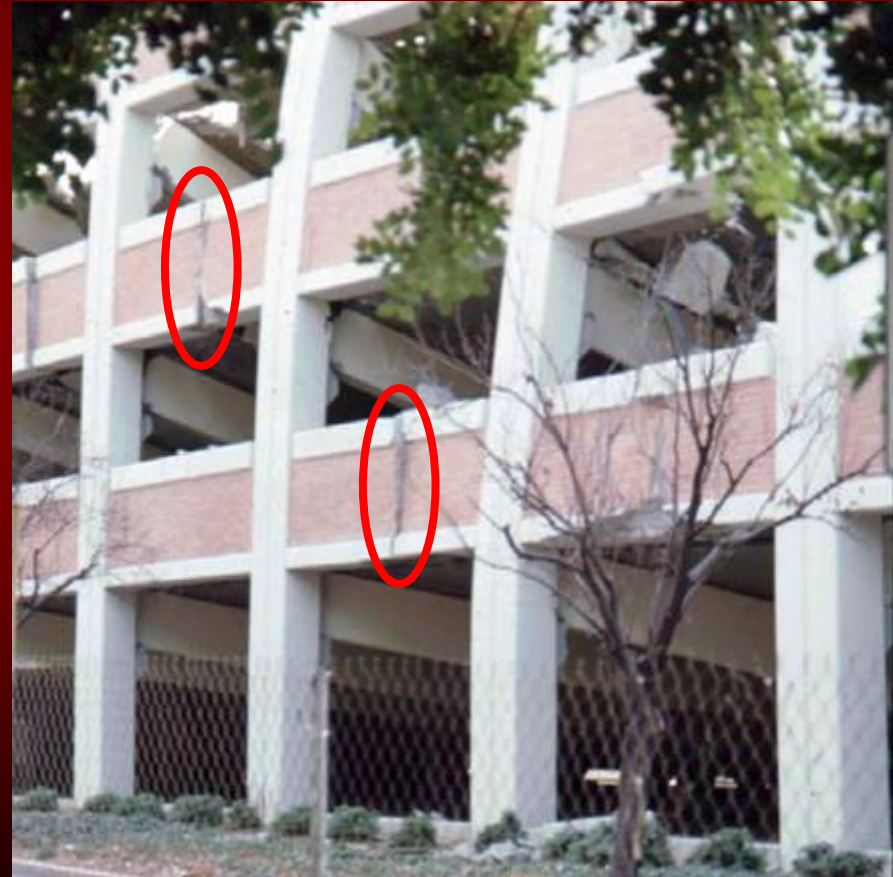
- Prefab tree elements split at intersections
