# Northridge Earthquake Failure

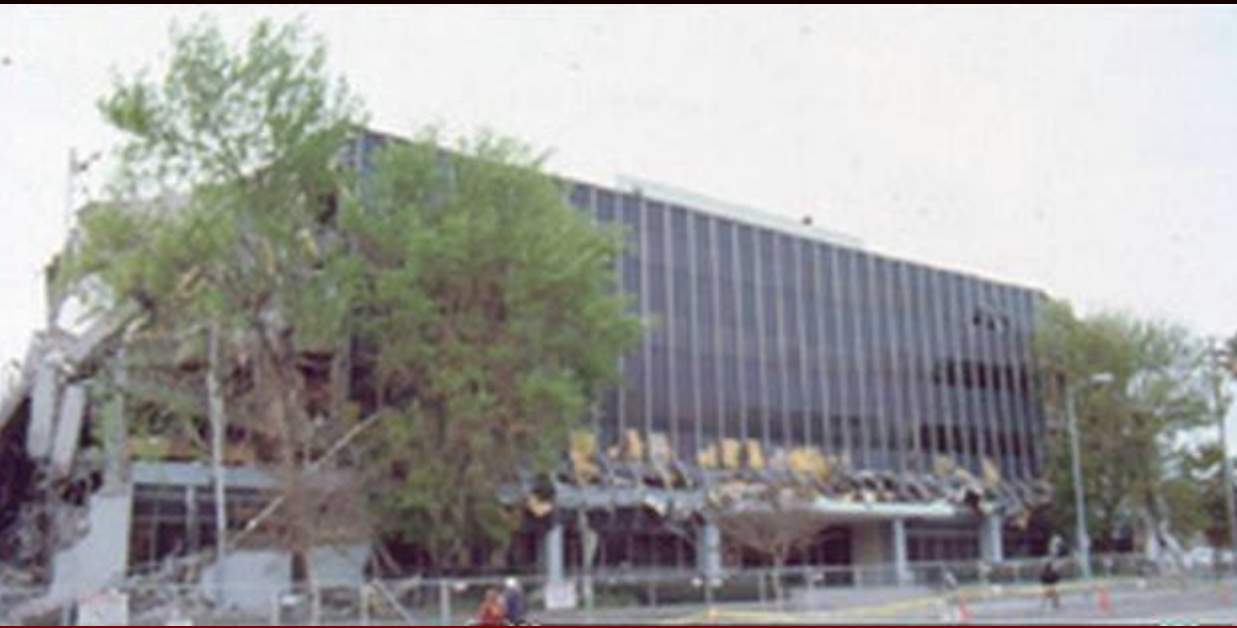
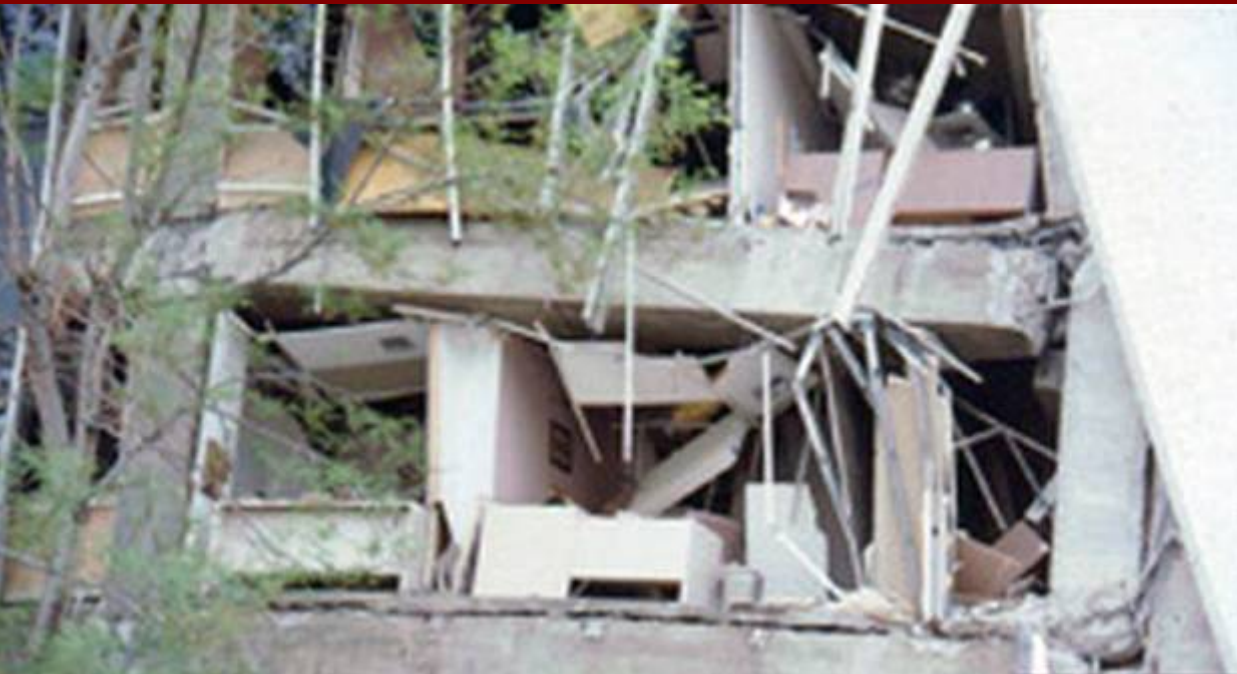
Medical center

Second story collapse

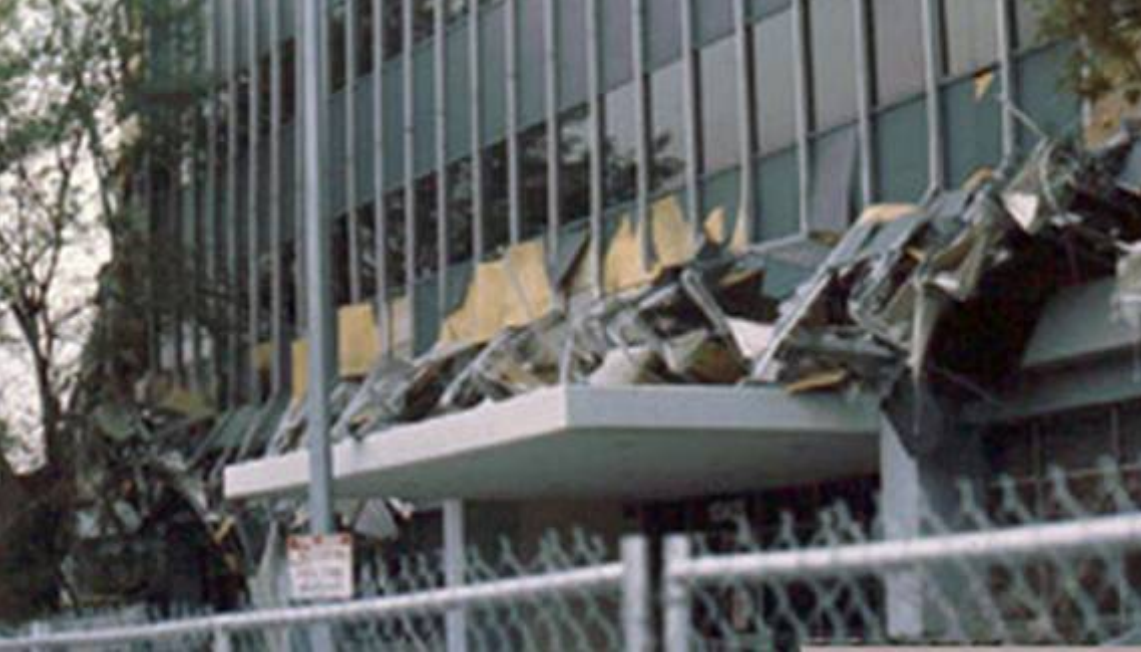
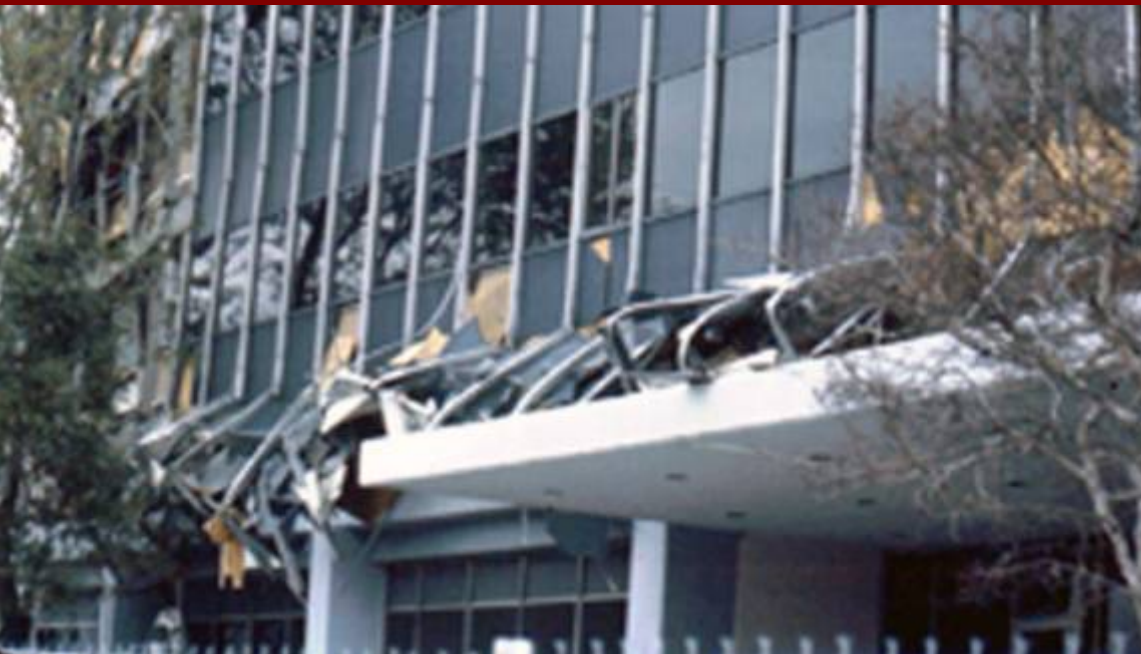
Medical center

Second story collapse

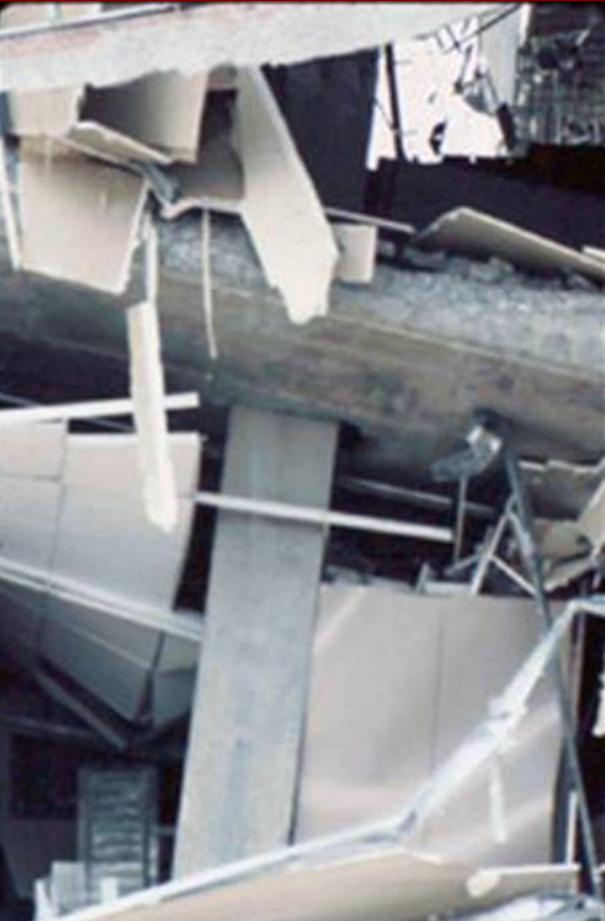
Column punctures  
concrete slab

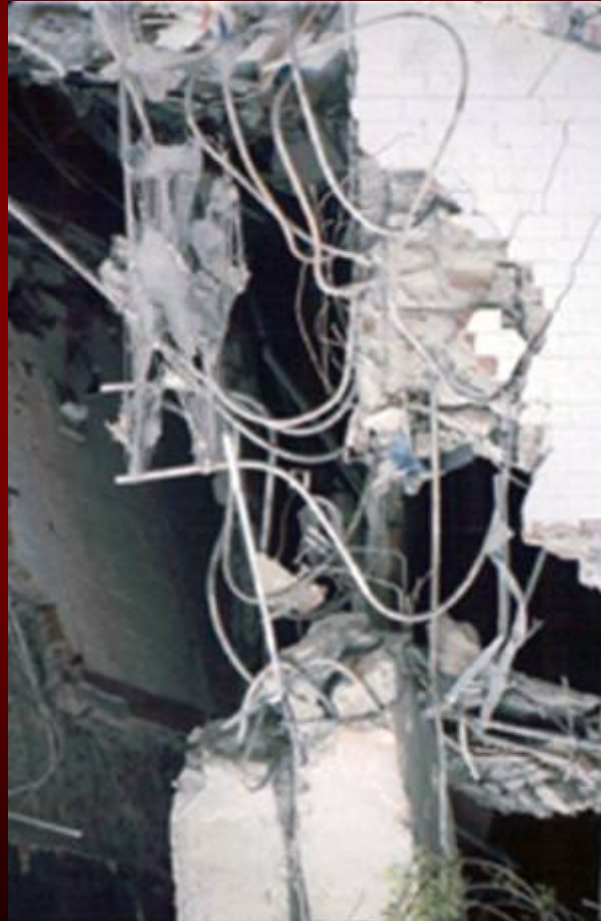
Exploded column

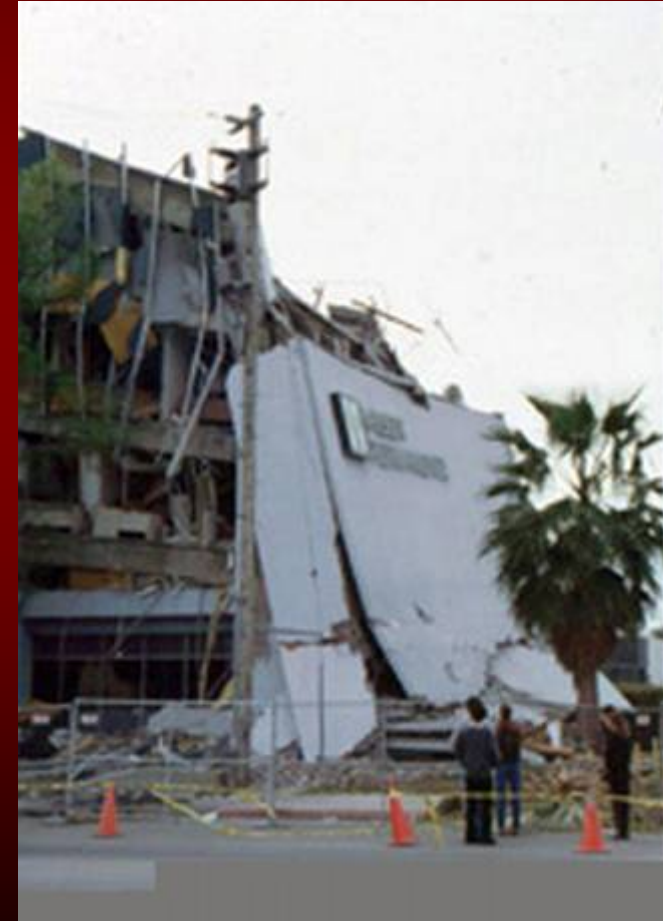
Collapsed side wall

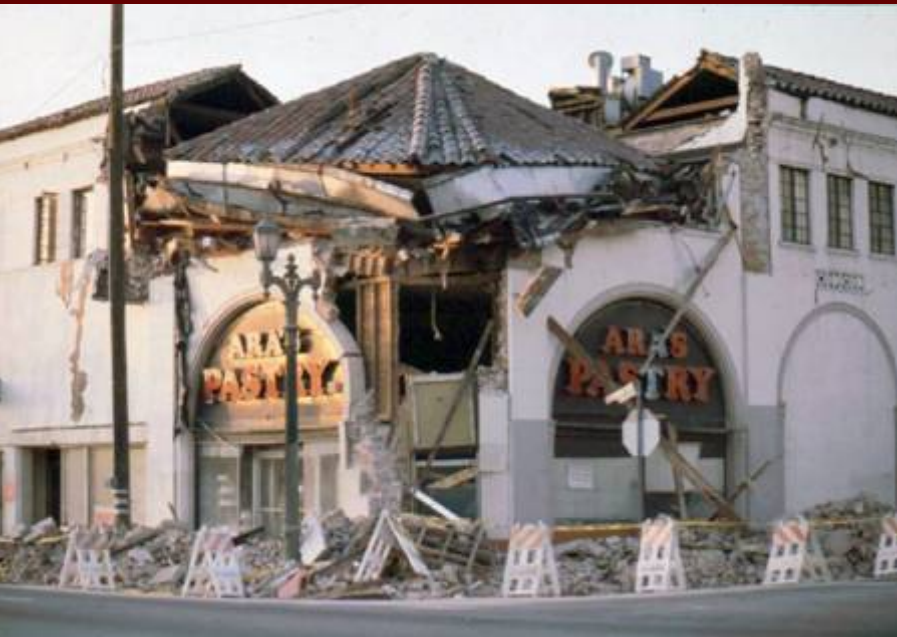
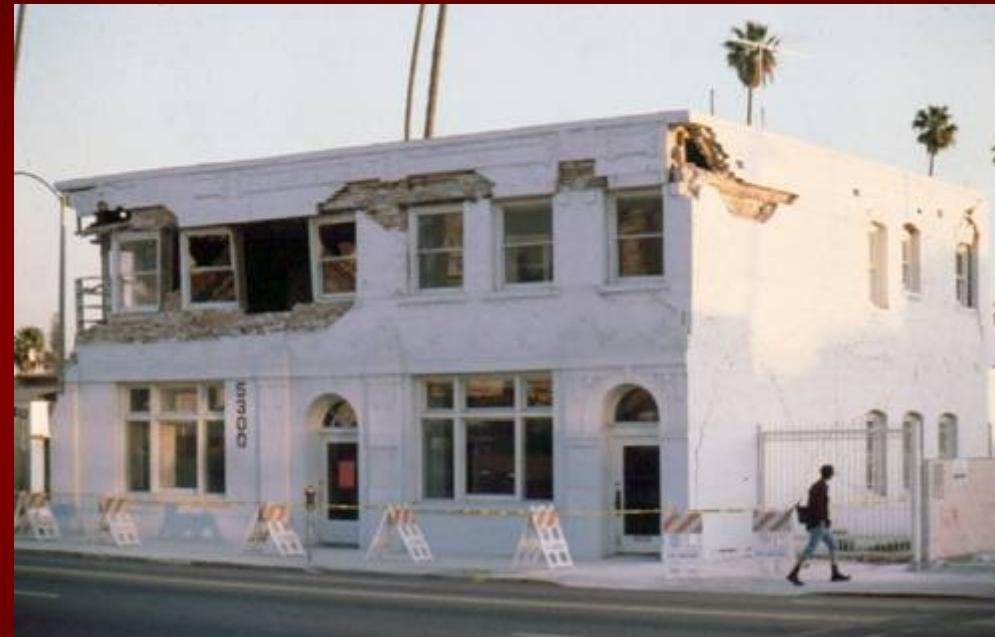
# Un-reinforced masonry failure

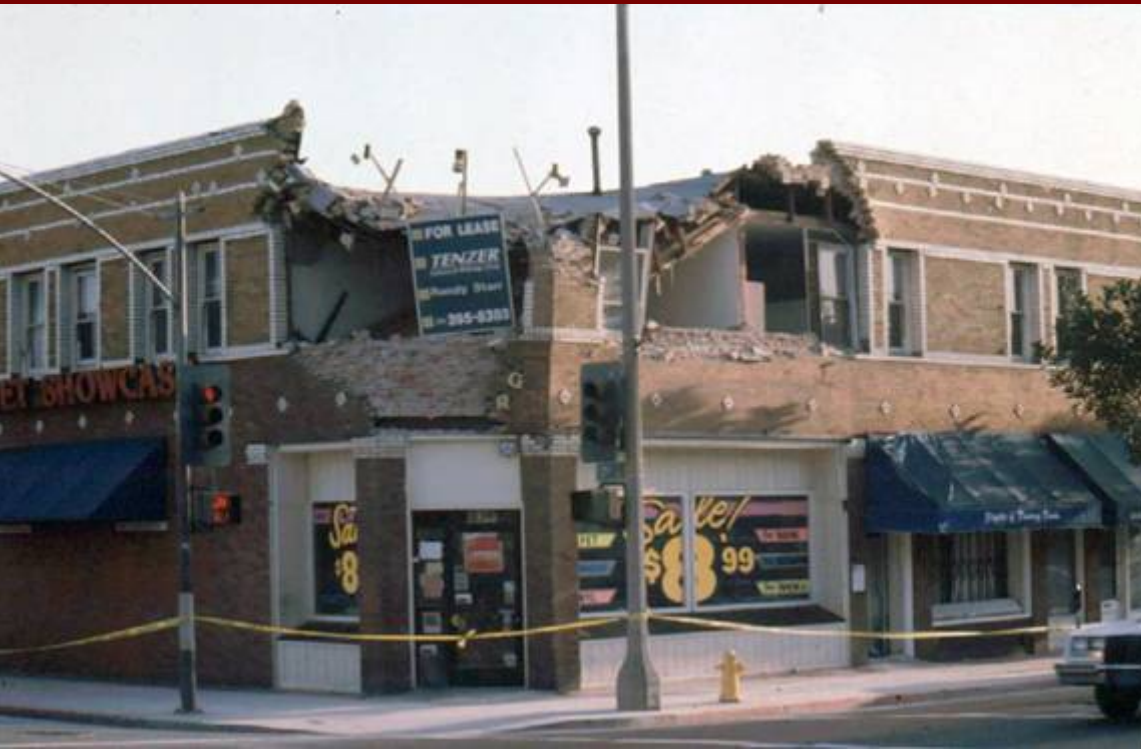
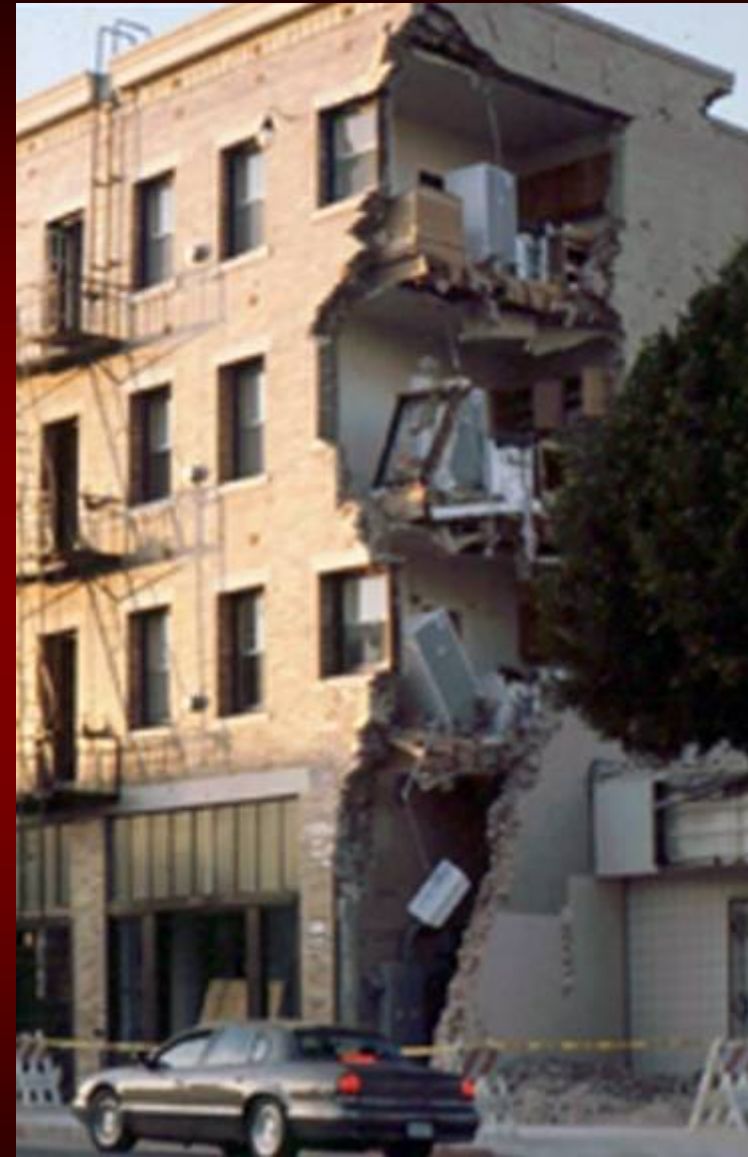
# Un-reinforced masonry failure

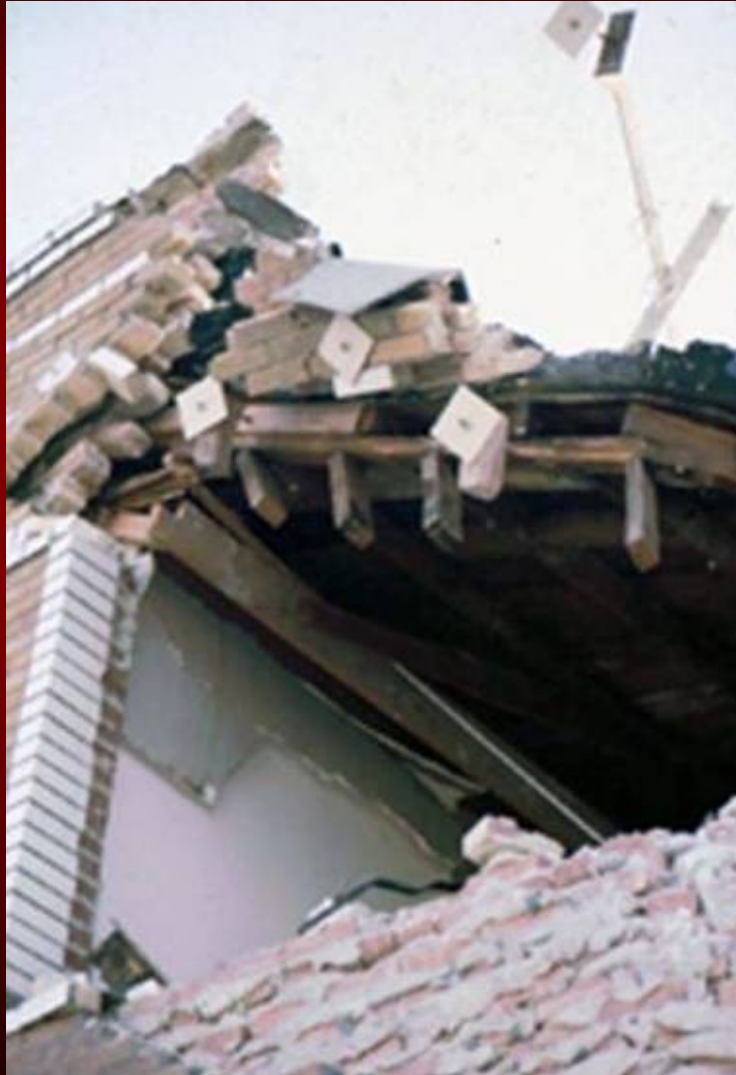
## Corner failure

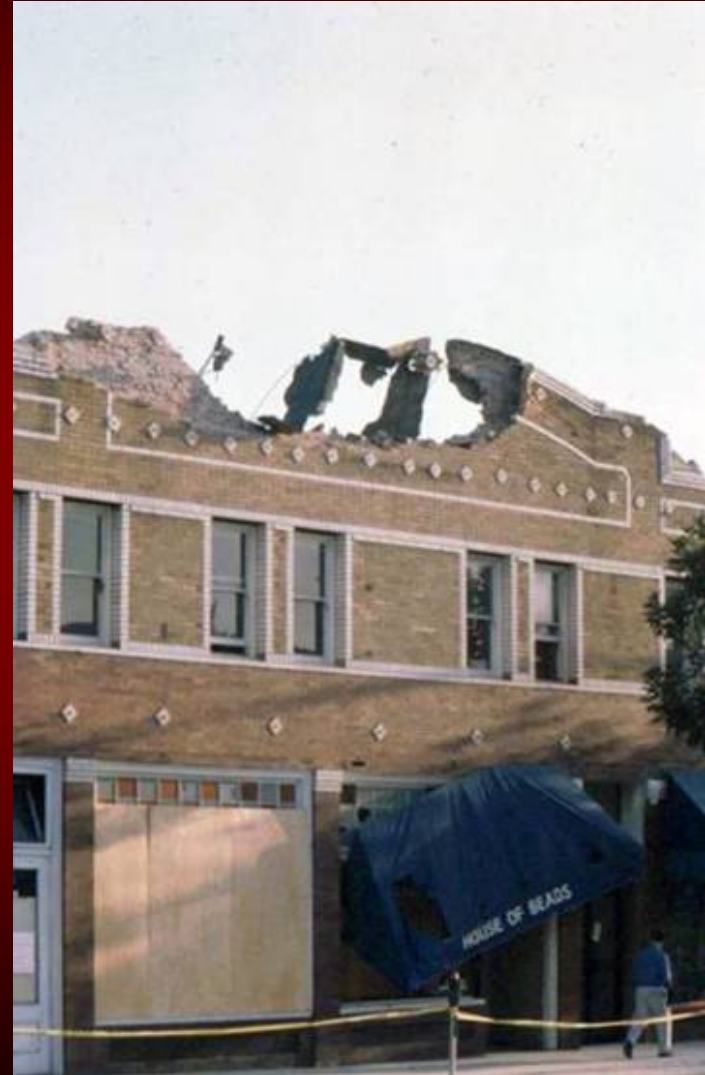
## Parapet failure

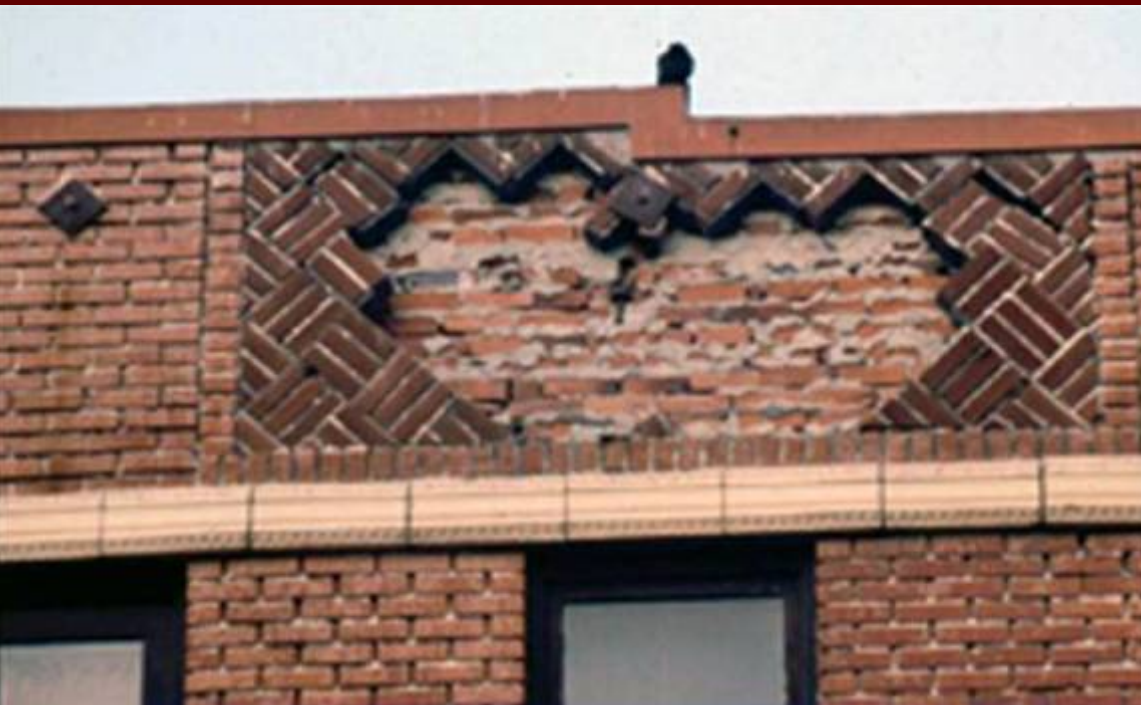
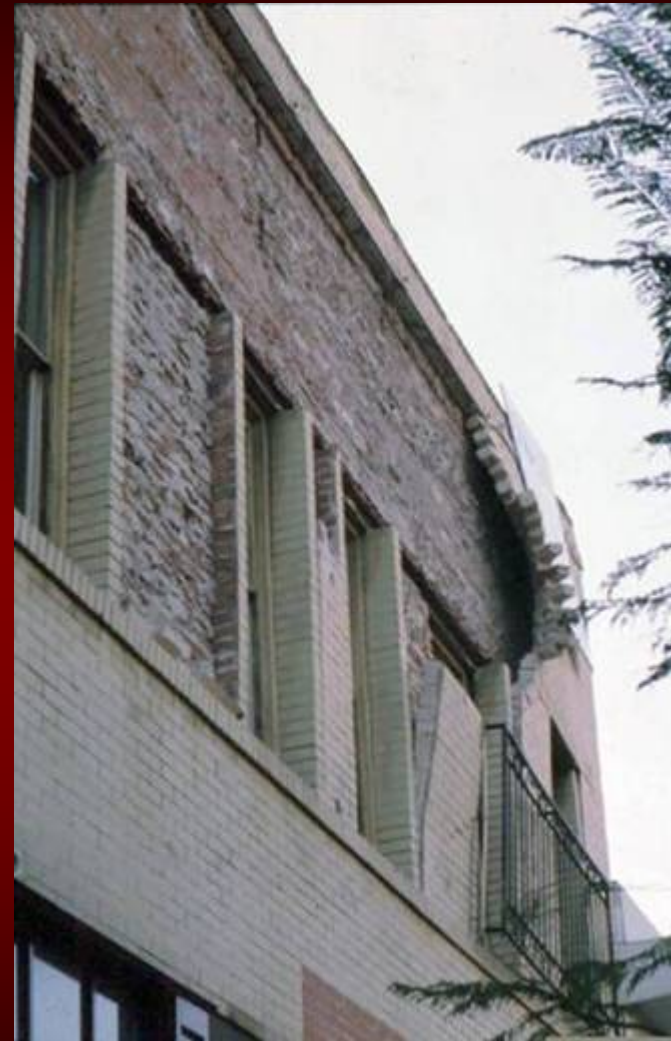
# Brick veneer failure

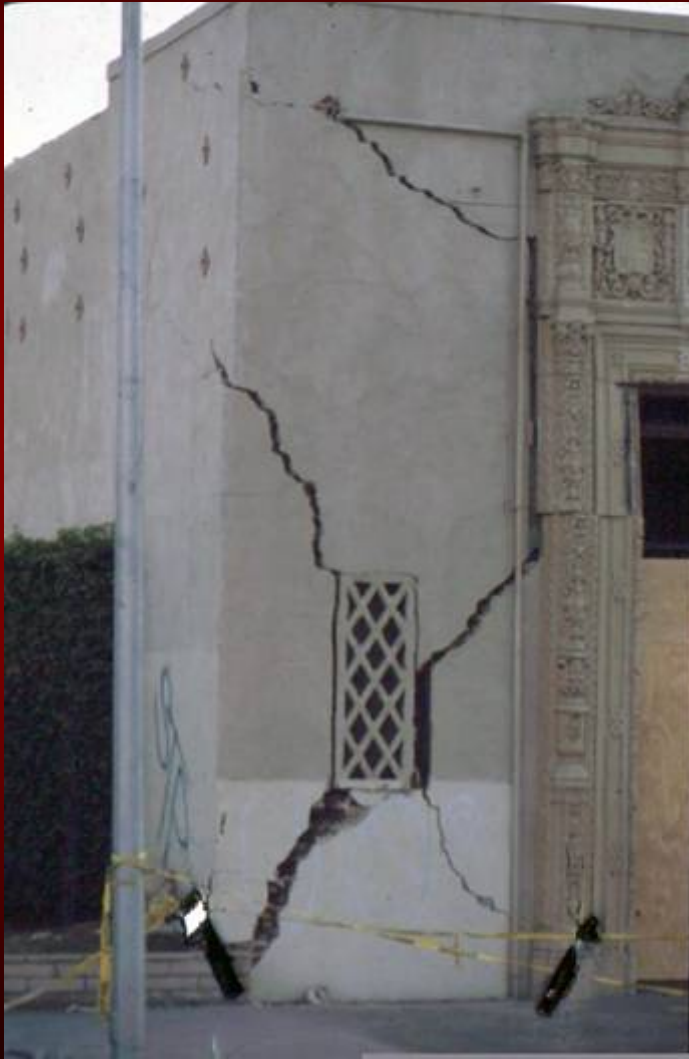
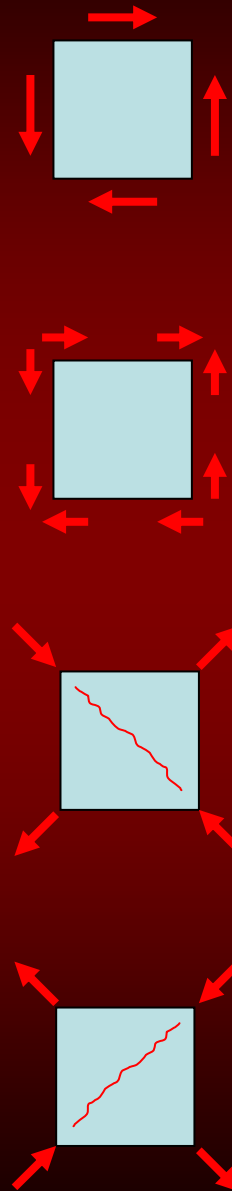
# Diagonal cracks

Narrow shear wall  
reduced by opening ☹️

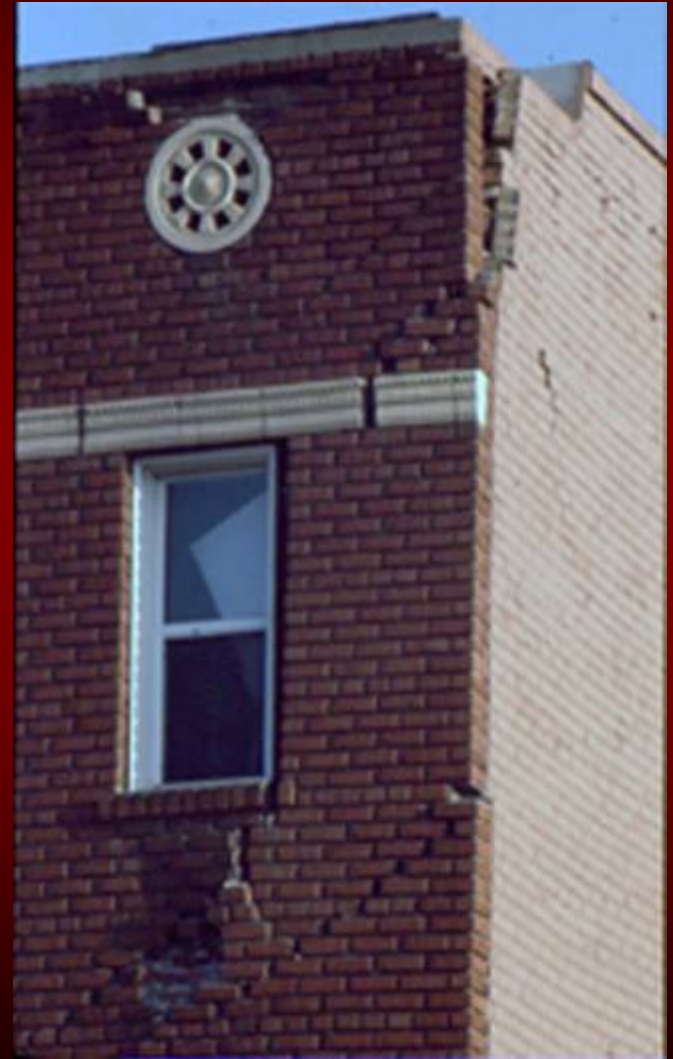
Corner failure

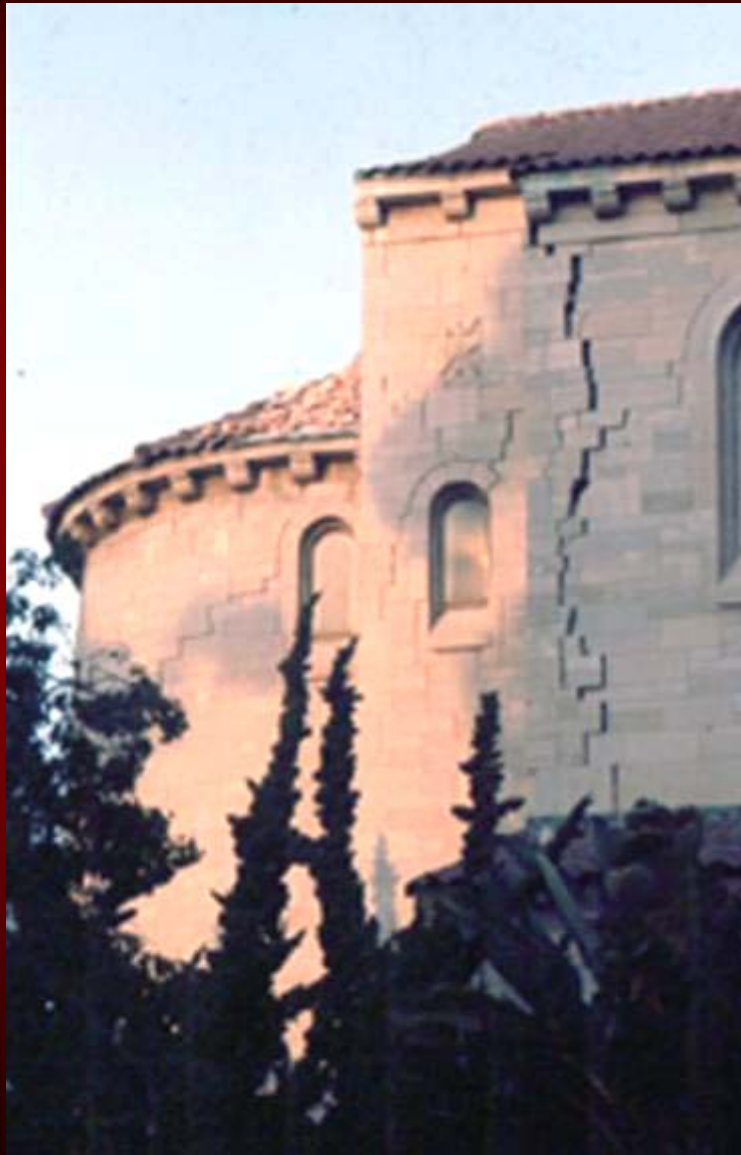
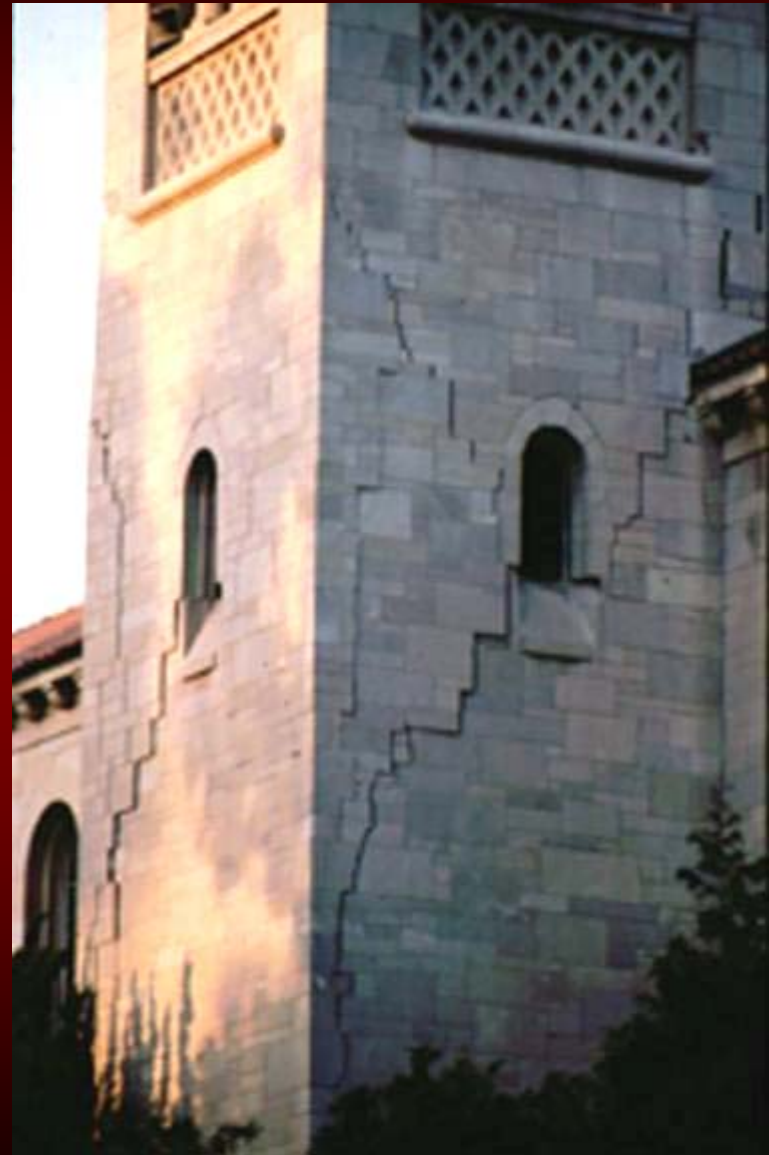
# Un-reinforced masonry cracks

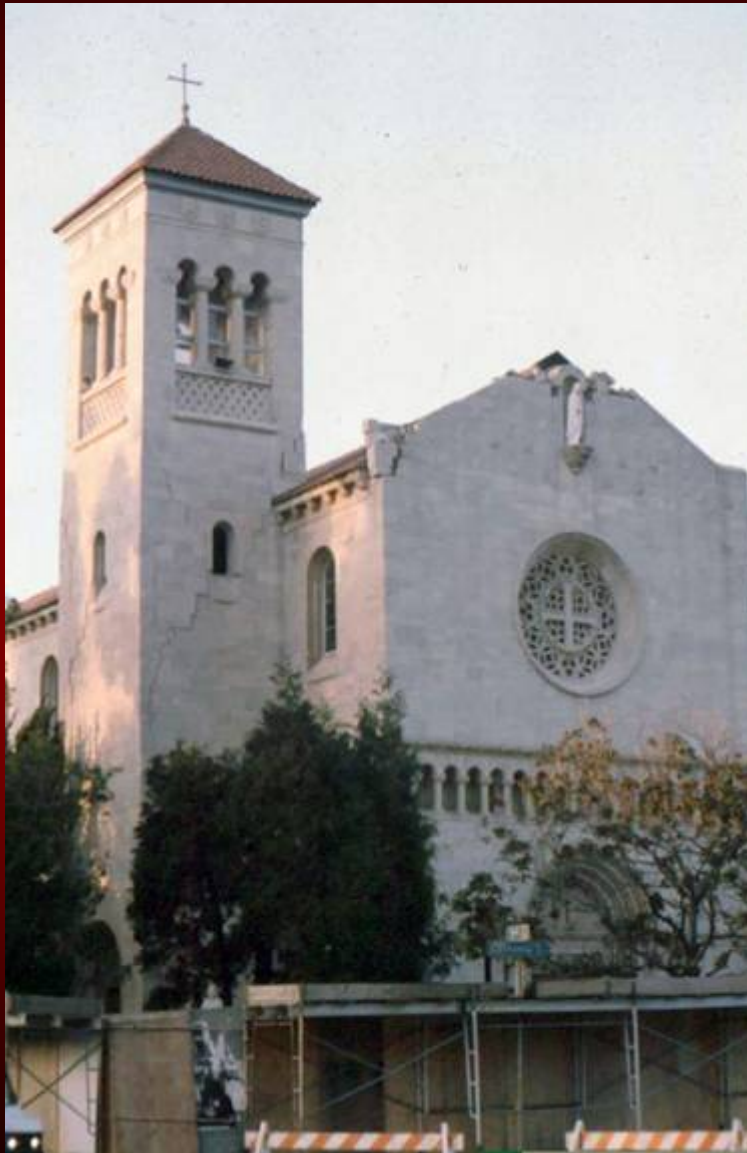
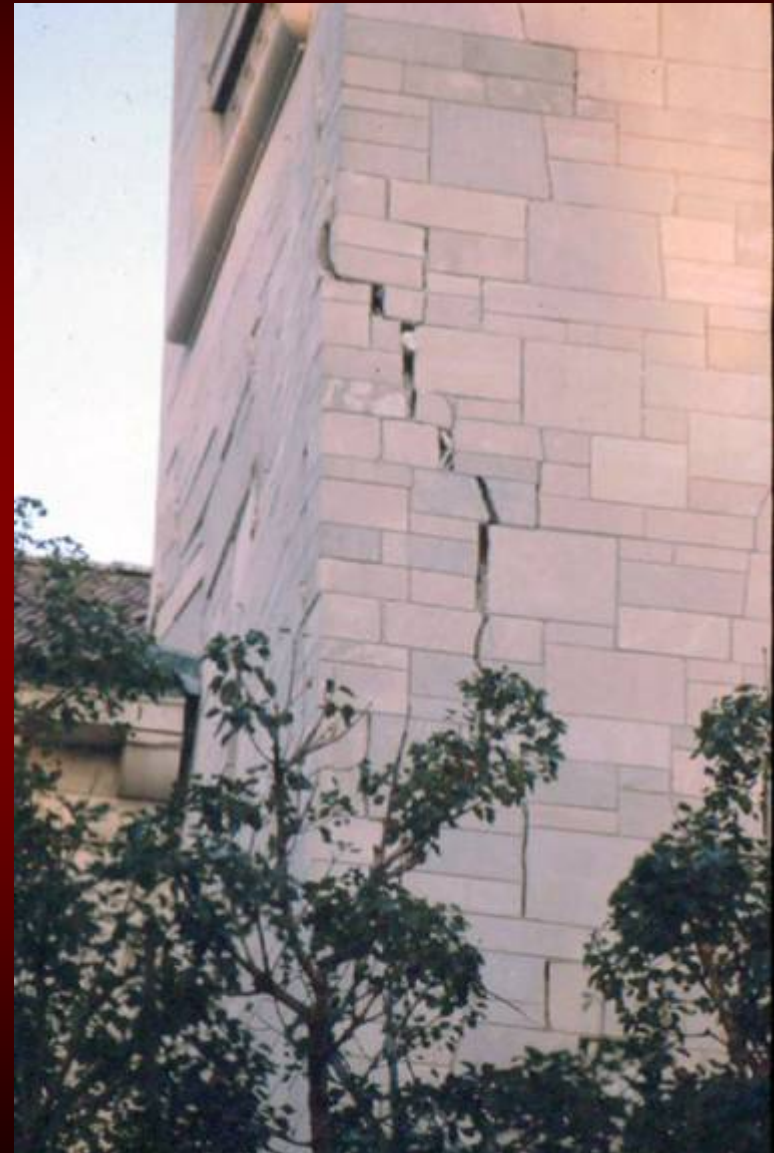
# Un-reinforced masonry cracks

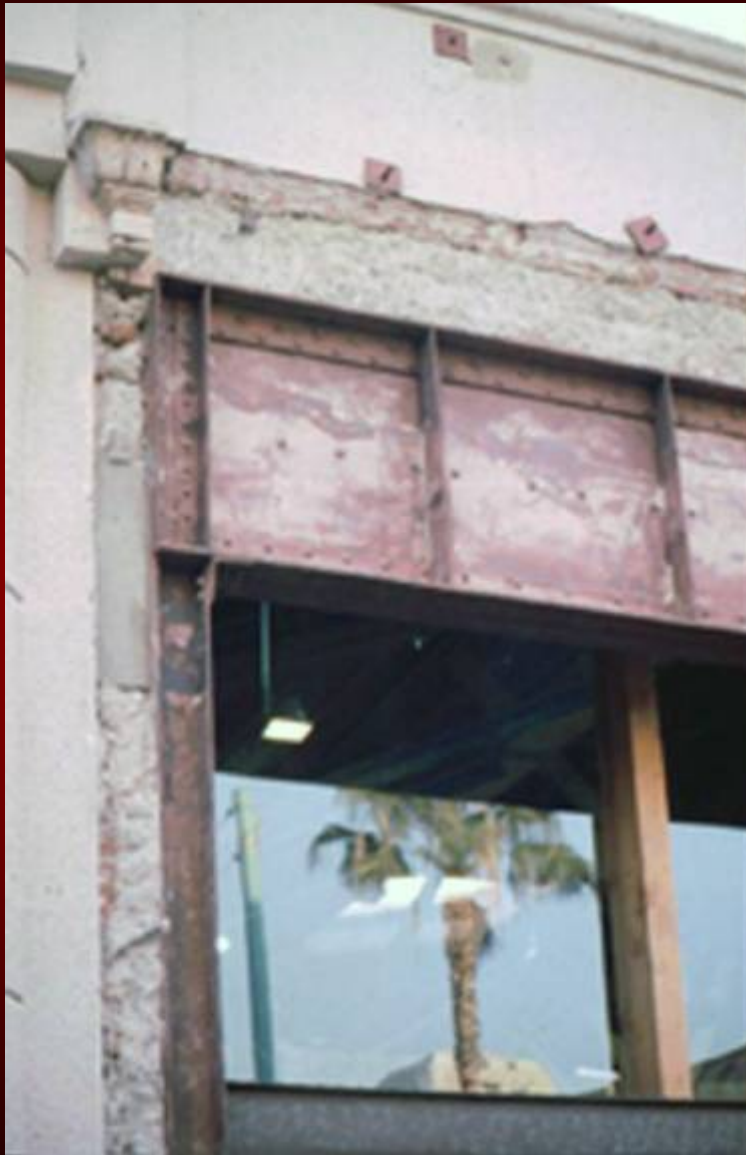
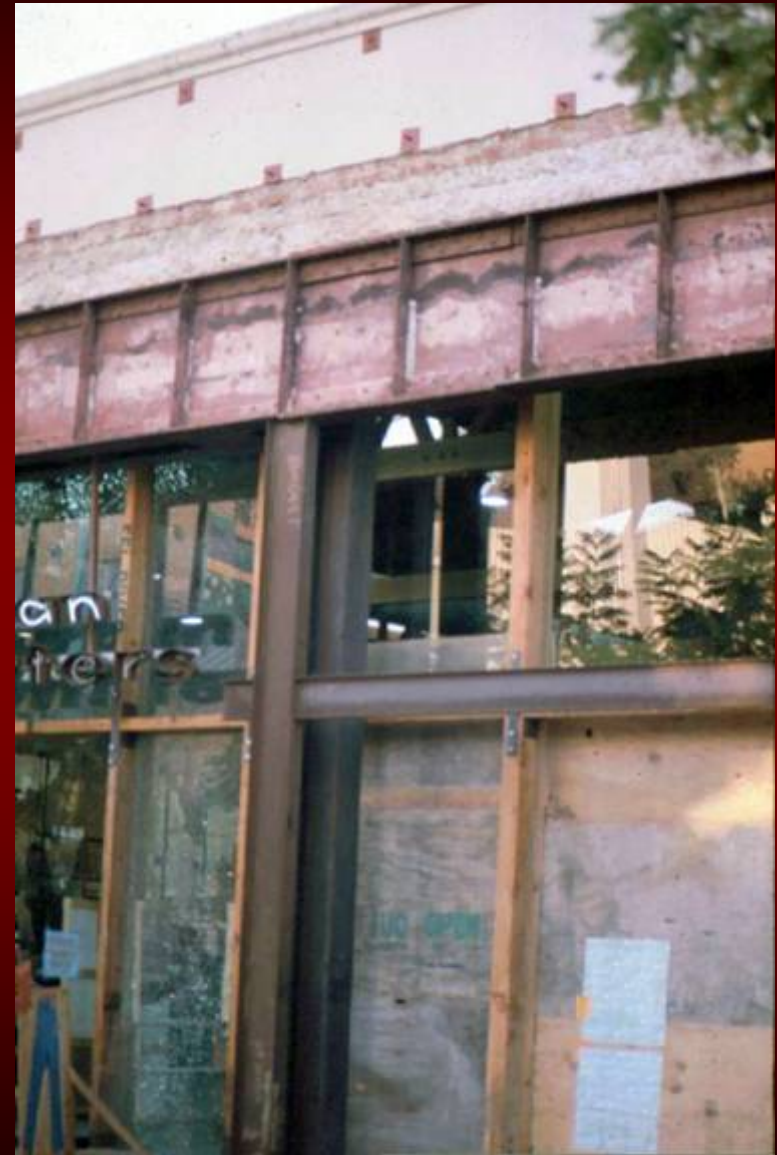
# Veneer peeled off steel frame (stiff veneer / flexible steel frame are incompatible)

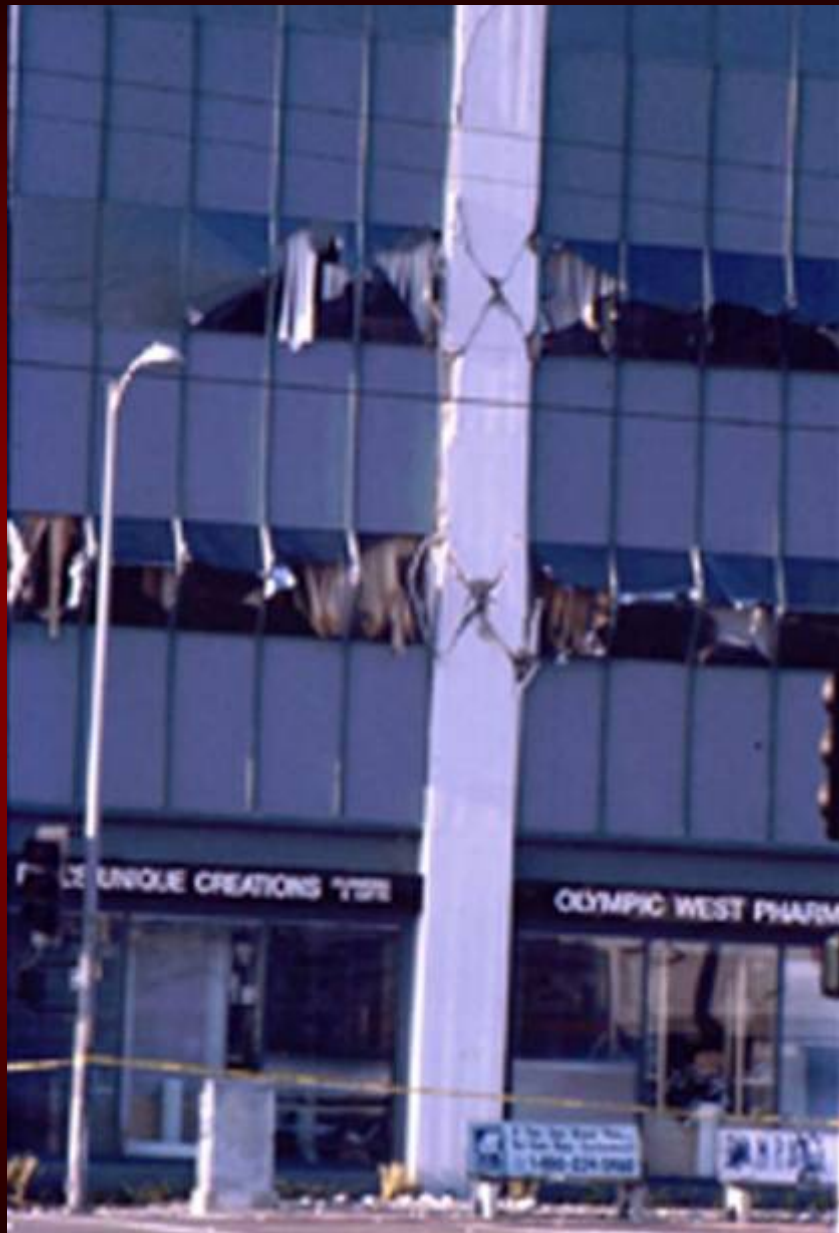
Column shear cracks  
required demolition

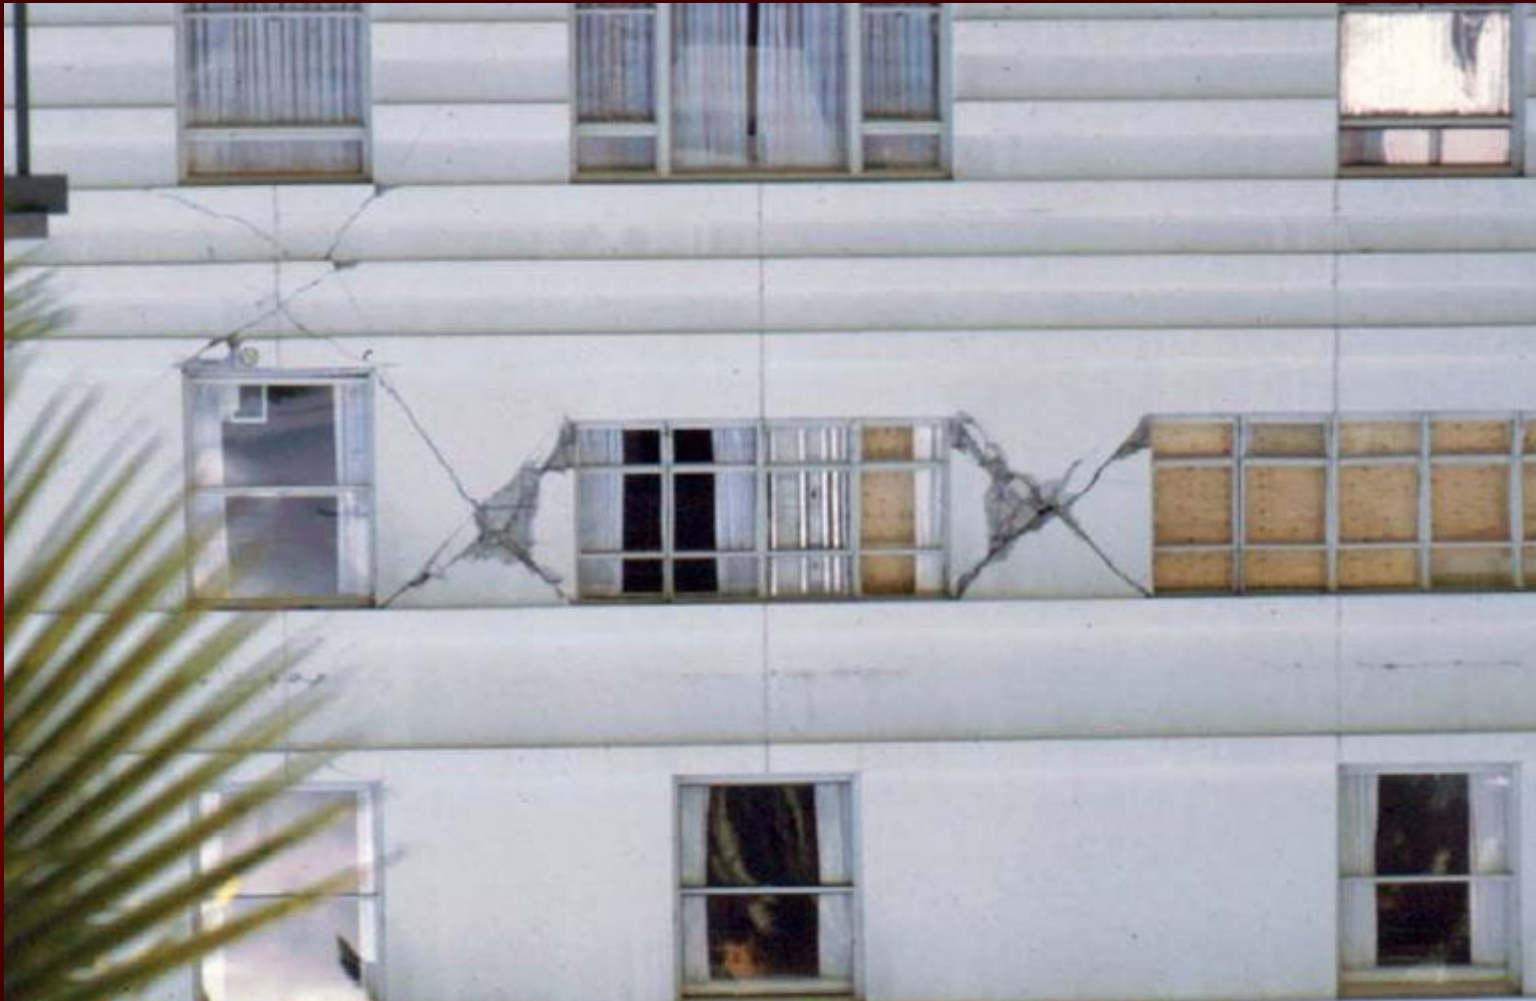
# Concrete wall with diagonal shear cracks

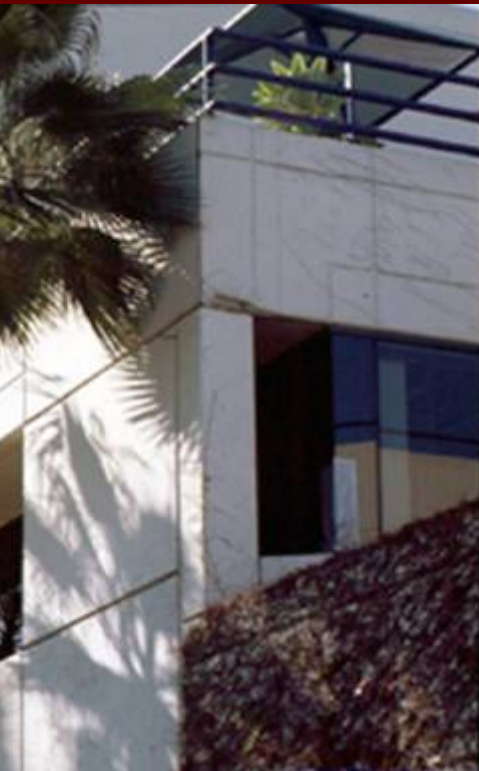
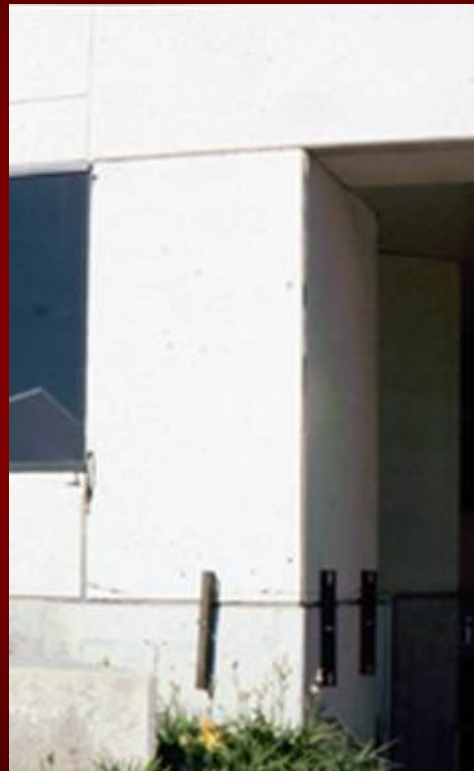
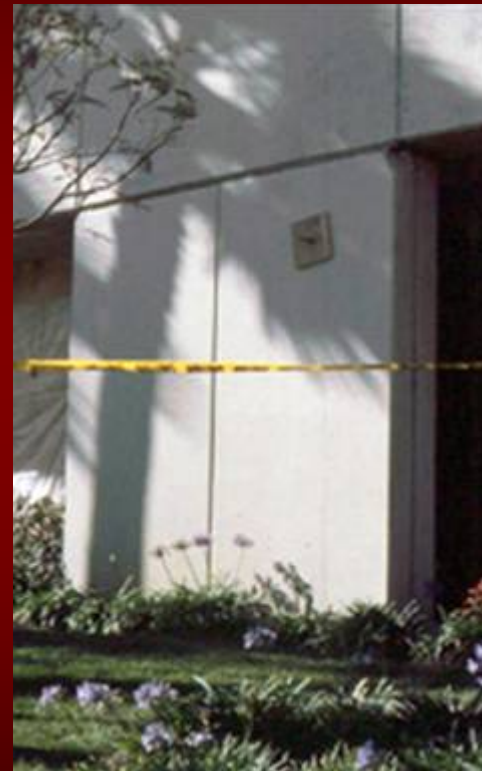
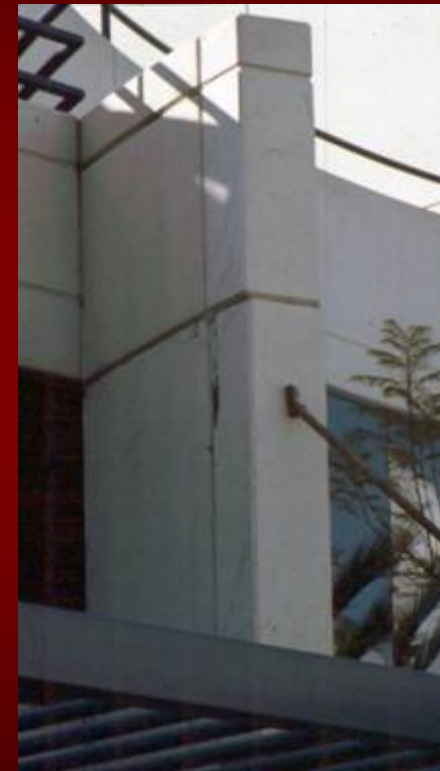
# Prefab concrete panels

(cosmetic damage appearance required major repair)

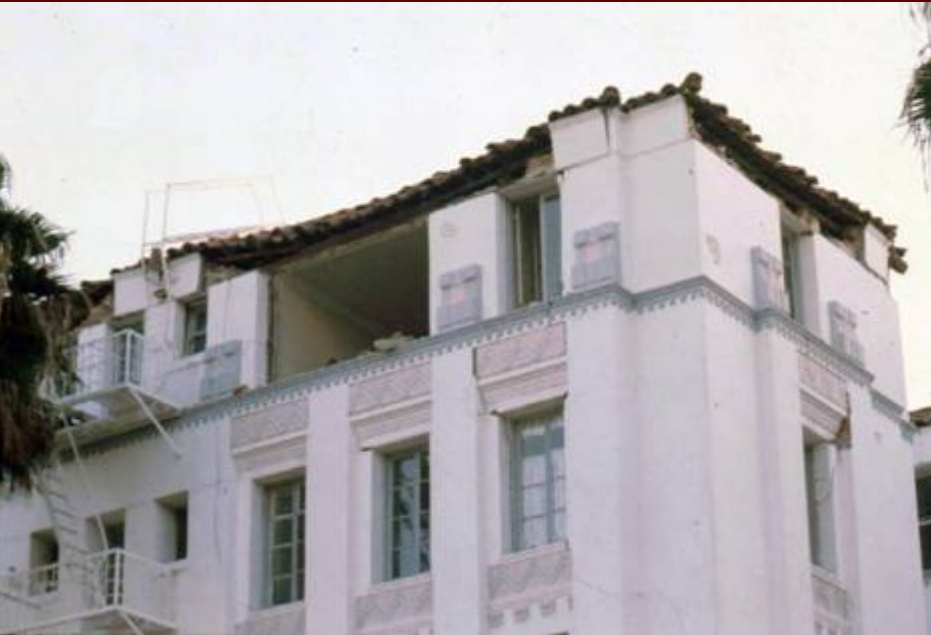
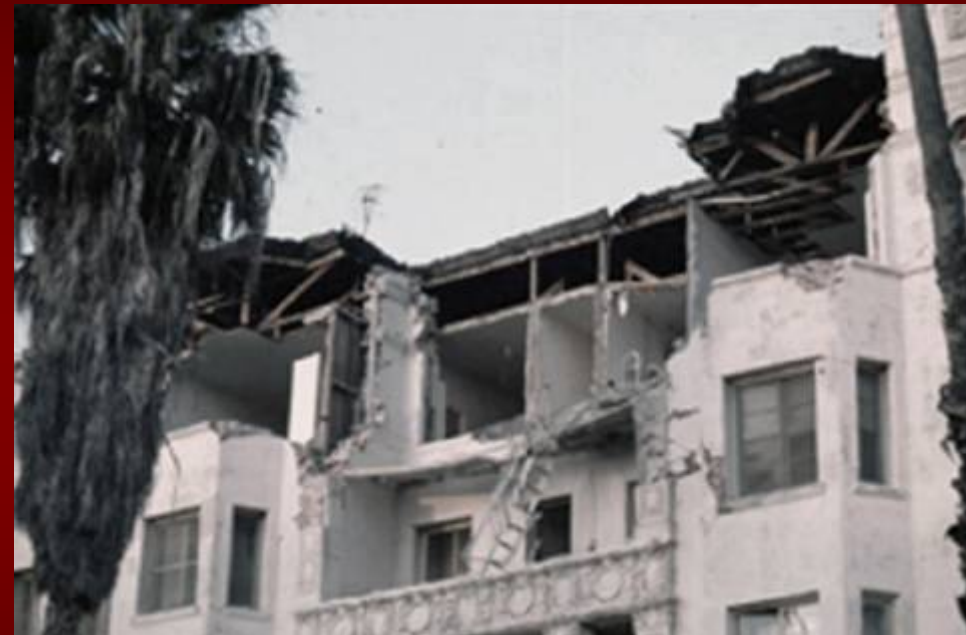
# Partial wall collapse
