# Northridge Earthquake Failure

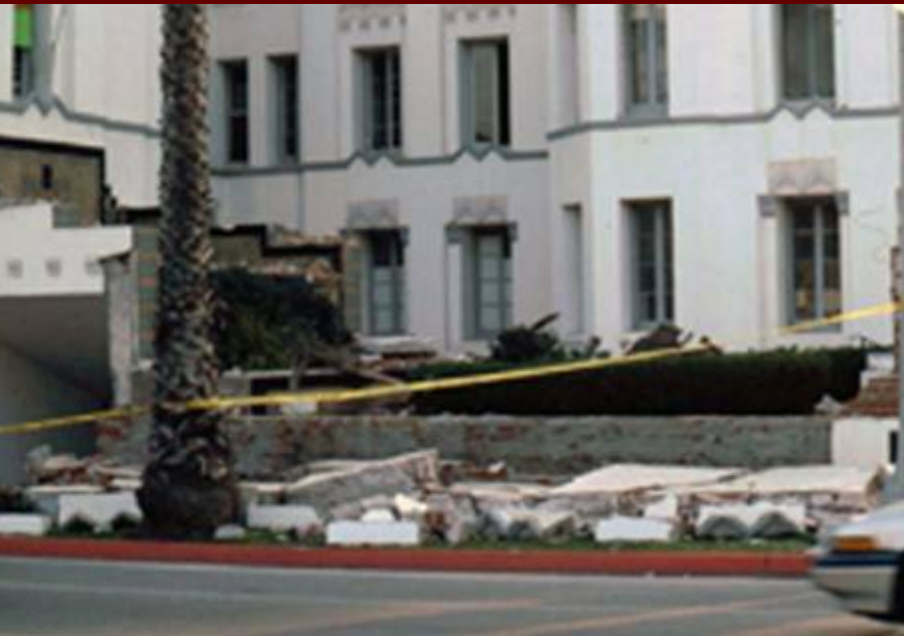
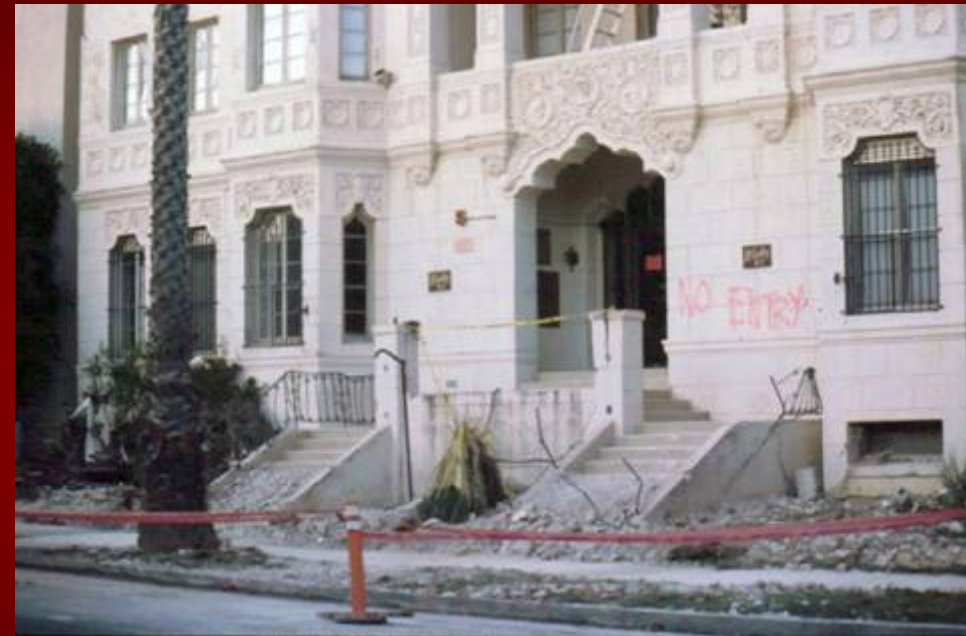
# Roof parapet debris on ground

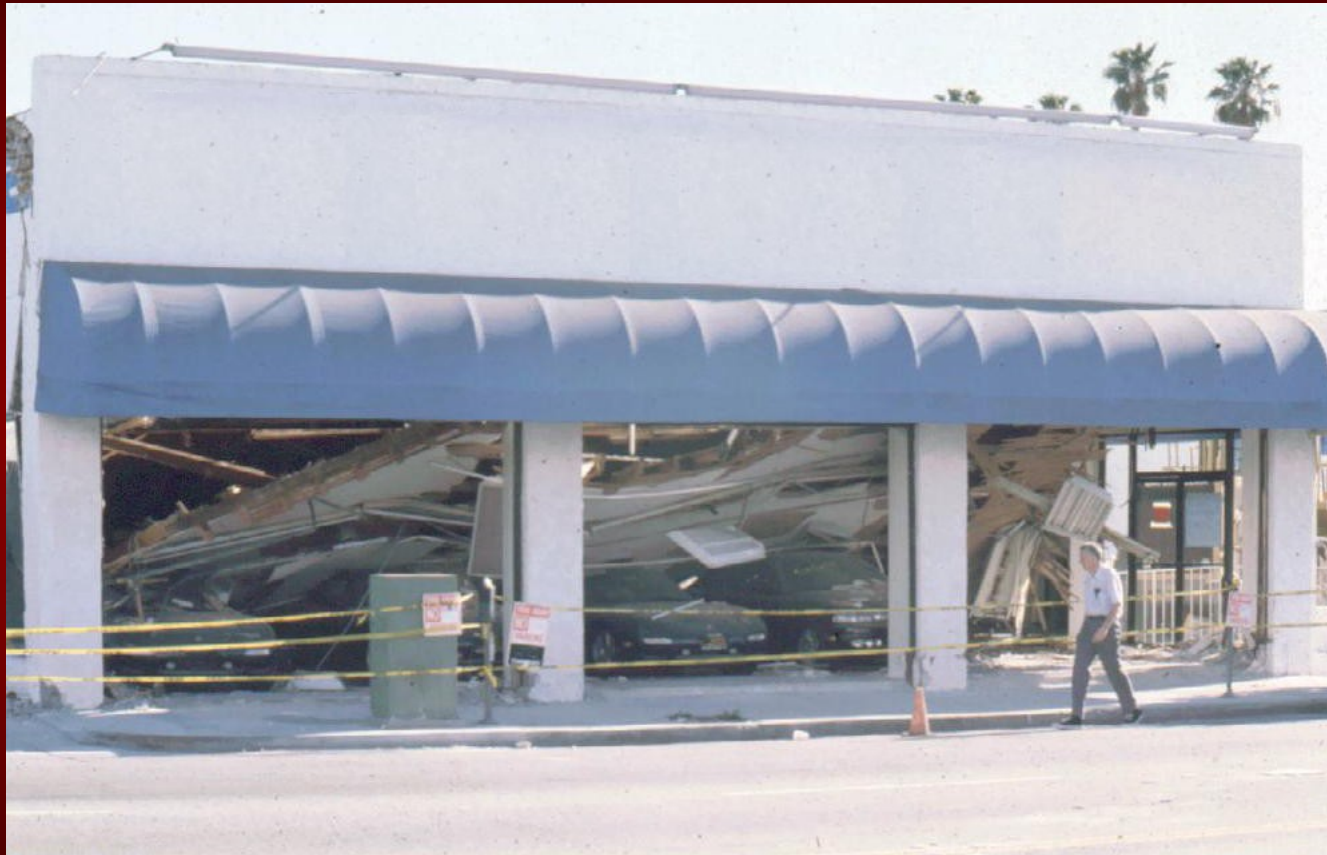
# Suspended ceiling failure

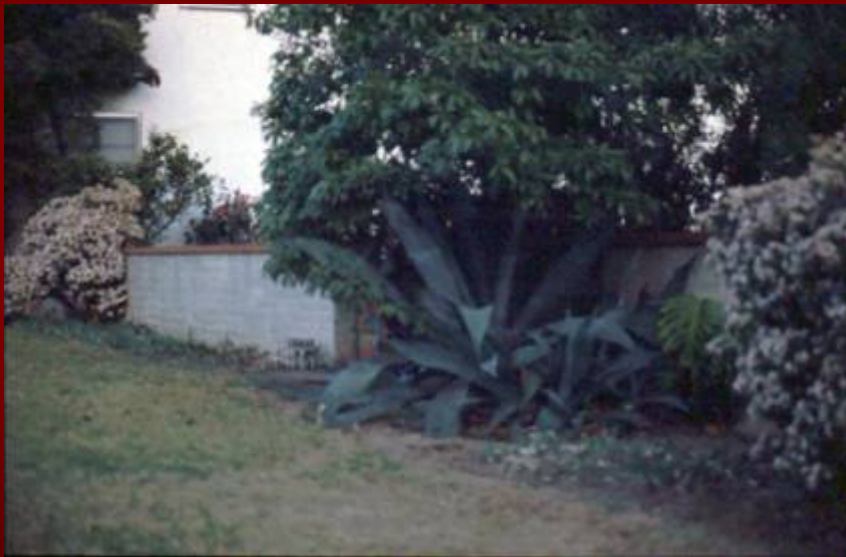
# Garden wall (effect of shaking direction)

East-west no damage

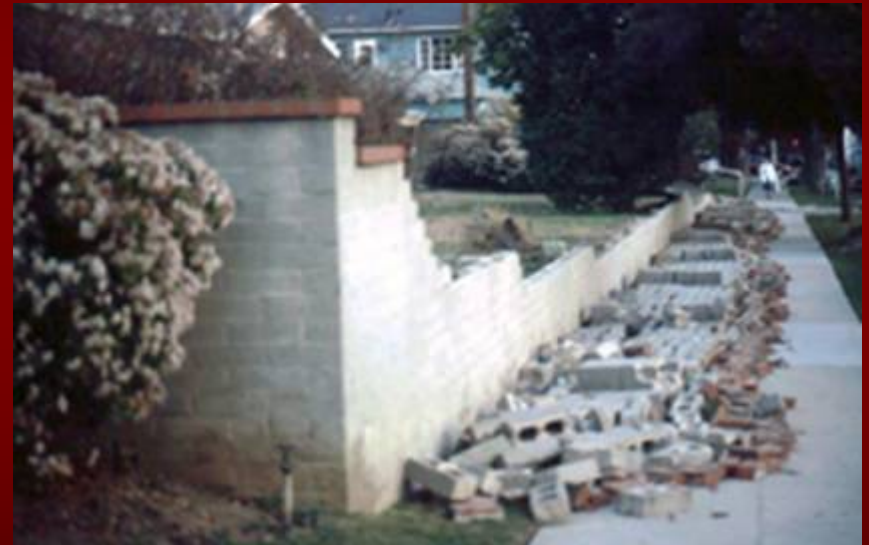
North-south collapsed

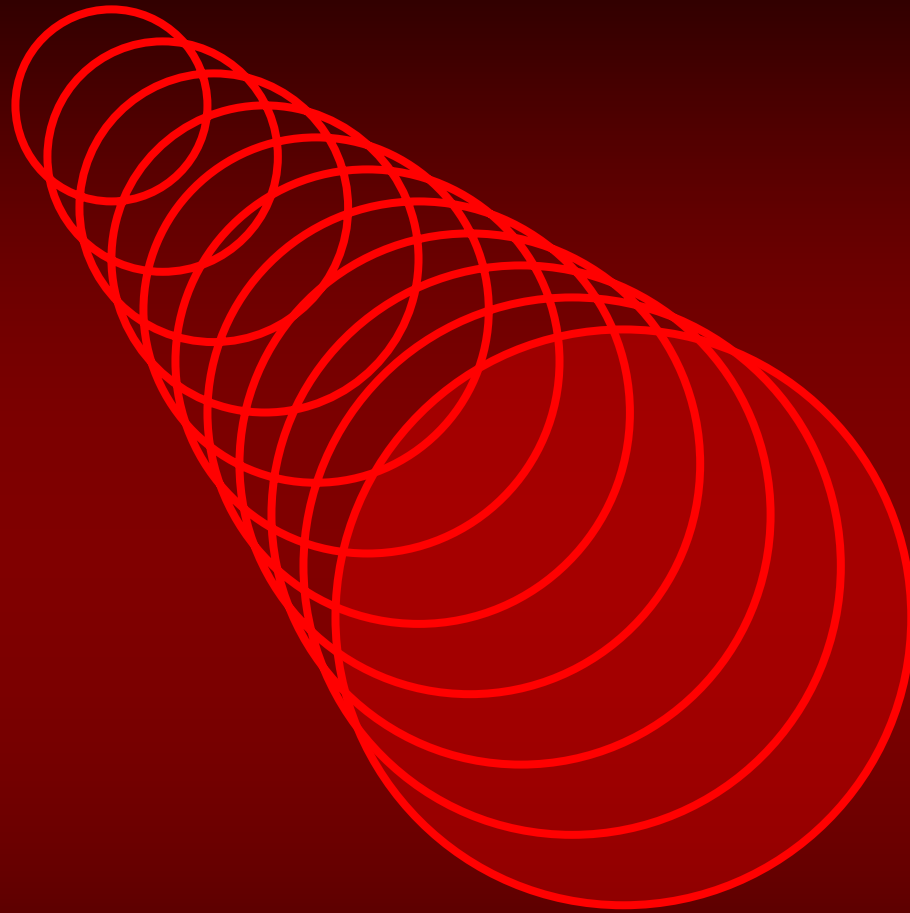
# **Seismic design prevents failure**
