State of Research on Seismic Retrofit of Concrete Building Structures in the US

Jack P. Moehle
Pacific Earthquake Engineering Research Center
University of California, Berkeley

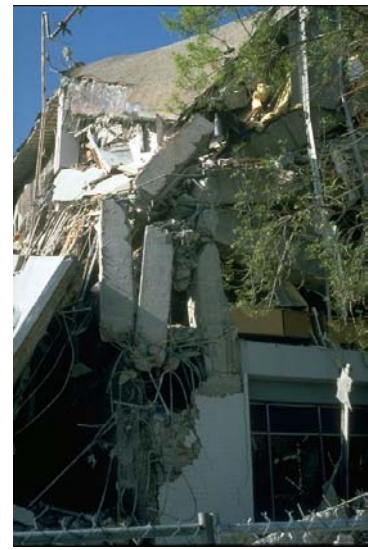
Figure 4 – Joint failures – Northridge earthquake

Failures of beam-column connections also have been observed. Figure 4 depicts an example from the Northridge earthquake.

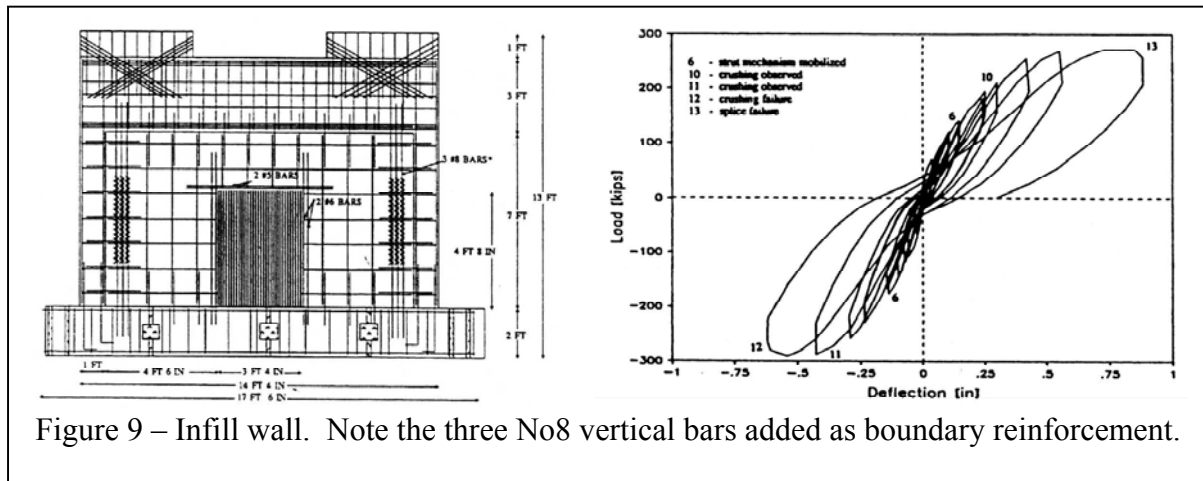
Jirsa and Kreger [Jirsa, 1989] have reported tests on one-story infill walls. Four specimens were tested. The first three varied in opening location: full infill, door opening, and window opening. Although the infill increased the strength of the frame, failure was relatively brittle owing to failure of the existing column lap splices. In a fourth specimen, new longitudinal reinforcement was placed adjacent to the existing columns to improve continuity of the tension chord of the wall. Strength and ductility were notably improved (Figure 9).

Figure 9 – Infill wall. Note the three No8 vertical bars added as boundary reinforcement.

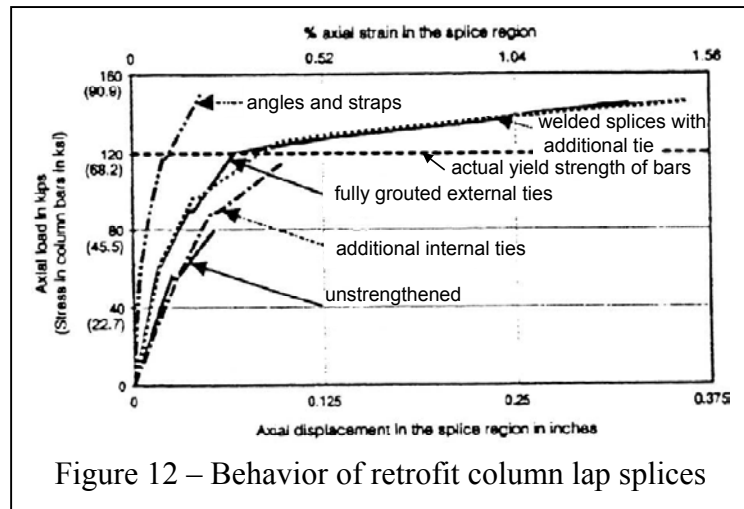
Figure 12 – Behavior of retrofit column lap splices

Behavior of existing column lap splices is important when the columns become boundary elements of infilled walls, as noted in the previous studies. Techniques for rehabilitating existing laps include removing cover concrete and welding overlapped bars, confining lap splices by steel or reinforced concrete jackets, and providing new reinforcement in a jacket. Valuvan et al. [Valuvan, 1993] reports results on in-situ column laps retrofitted by welding, steel angles, and external and internal hoops. Behavior of the specimens retrofitted by steel elements was varied, as it was difficult to match the steel elements with the existing concrete surface. The specimens with steel ties also exhibited varied performance; grouting the ties proved to be essential to good behavior. Behavior of the specimens with internal ties was

unsatisfactory, possibly because chipping the cover concrete to place the new ties resulted in irreparable internal damage. Figure 12 summarizes some of the results.

Lap splices of column longitudinal reinforcement can be improved by several techniques including removal of cover concrete and welding overlapped bars, confining the lap by steel or reinforced concrete jackets, and providing new longitudinal reinforcement in a jacket. Aboutaha et al. [Aboutaha, 1996] report on use of steel jackets to confine inadequate laps. The tests showed that the retrofit approach can be effective using thin steel jackets augmented by a small number of adhesive anchor bolts. The anchor bolts stiffen the thin plates, and are especially important as the column width increases. Alternative approaches were investigated by Valluvan et al. [Valluvan, 1993], as described previously (Figure 12).

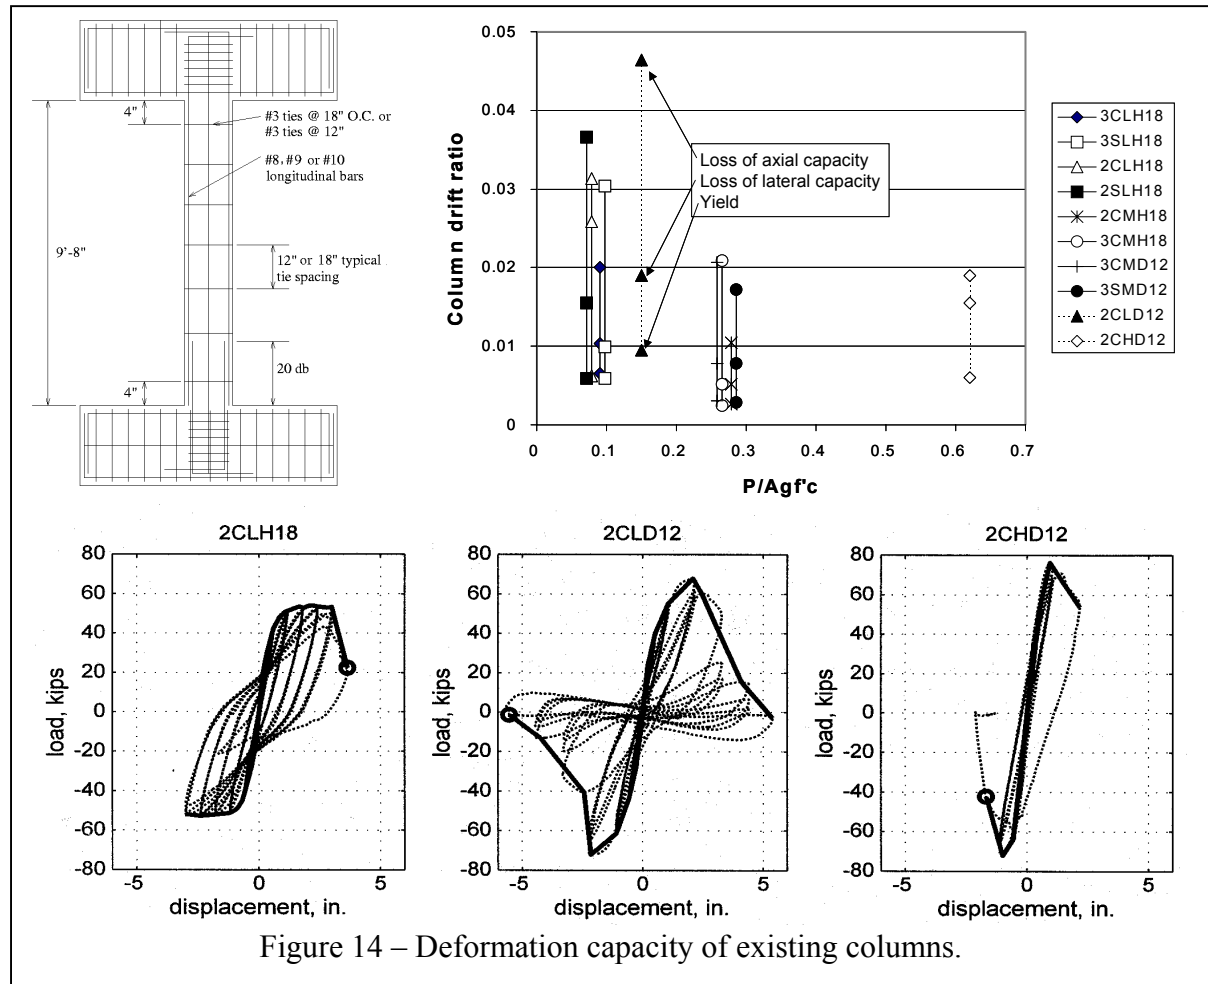
Figure 14 – Deformation capacity of existing columns.

Research on reinforced concrete columns aims to understand behavior in flexure, axial load, shear, and bond (especially as this relates to failure of lap splices). Studies by Lynn et al. [Lynn, 1996] and Moehle [Moehle, 1999] have examined shear strength, lap-splice strength, and deformation capacity as limited by loss of axial load. As shown in Figure 14, axial load capacity often is maintained to deformations well beyond the point where lateral load capacity is exhausted – most reported experiments do not clearly identify where axial load failure occurs. Deformation capacity at collapse depends on the failure mechanism (flexure versus shear) and the level of axial load.

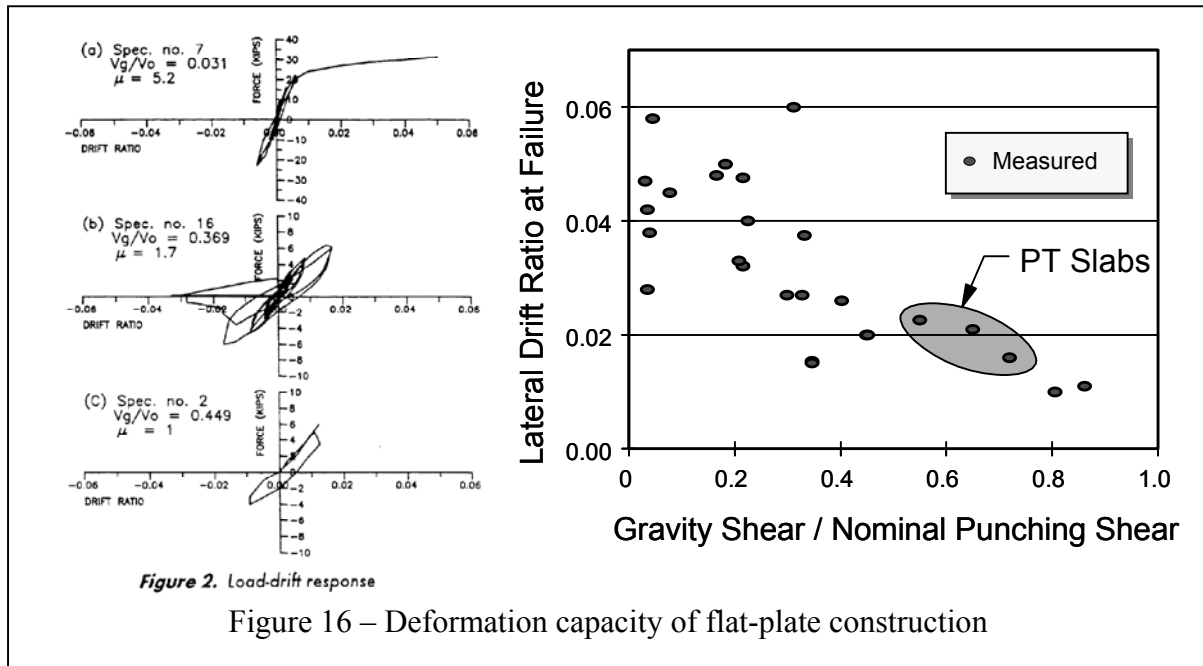
Figure 16 – Deformation capacity of flat-plate construction

Pan and Moehle [Pan, 1989] reported on deformation capacity of reinforced concrete flat plate construction, identifying a simple rule relating deformation capacity and gravity shear level for typical construction (Figure 15). Martinez, et al. [Martinez, 1994] extended this work to post-tensioned flat-plate construction. Studies of details consistent with older construction have been reported by Dovich and Wight [Dovich, 1996] and Durrani???

Punching shear failure of two-way slabs was discussed previously (Figure 16). The consequences of shear failure depend largely on the details of the reinforcement at the connection. Following initial punching, continuous bottom reinforcement passing through the column can suspend the slab on the column by catenary action, thereby preventing progressive collapse that can result in pancaking of an entire building. Continuous top bonded reinforcement is less effective in suspending the slab. Continuous post-tensioning reinforcement located near the top surface of the slab has been found to be effective in suspending the slab after punching failure [Martinez, 1994].

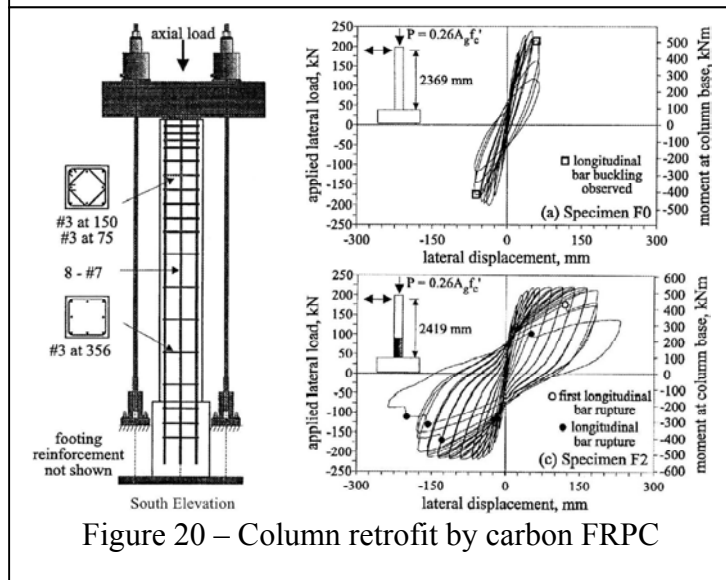
Figure 20 – Column retrofit by carbon FRPC

More recent work has emphasized applications of composites. Harries et al. [Harries, 1998] report on use of carbon fiber reinforced polymer composite (FRPC) jackets to retrofit non-ductile columns. Design of the jackets was based on providing sufficient confinement pressure while limiting the tensile strains in the jackets. They were effective to confine the flexural plastic hinge zone without significantly increasing strength or stiffness (Figure 20). Eventual column failure resulted from deterioration of the compression zone and longitudinal reinforcement buckling in the hinge region, suggesting that greater out-of-plane stiffness is required for the jacket.

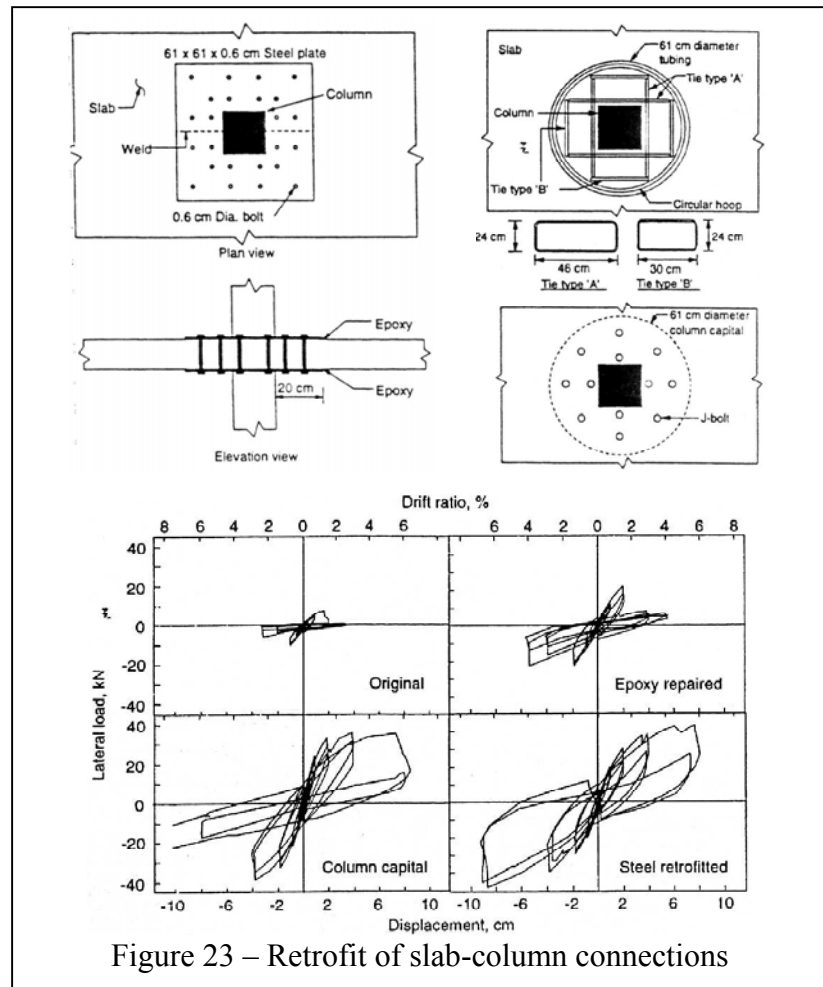
Figure 23 – Retrofit of slab-column connections

Several approaches to retrofitting deficient slab-column connections have been proposed. Masri [1996], Lou [1994], and Martinez [1994] have reported using steel or concrete drop panels added below the slab to increase the punching shear perimeter and therefore the shear strength. Martinez [1994] also presented results of tests in which the slab was retrofit using steel plates on both sides of the slab with through-bolts to act as shear reinforcement. The steel plate was epoxied to the slab. The concrete capital solution was achieved by chipping out the concrete around the column and recasting the slab with the capital. Both solutions were effective.
