Seismic Retrofit of Existing Buildings: Innovative Alternatives

Moe Cheung and Simon Foo
Public Works & Government Services Canada
Hull, Quebec, Canada

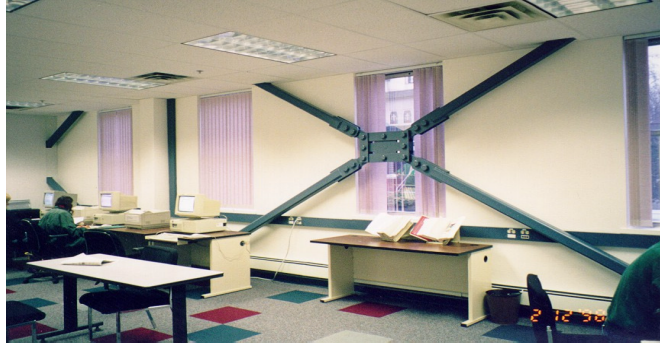
Figure 1 Harry Stevens building: X-braced friction damper

Friction damper, consisting of specially coated steel plates being bolted together, is usually part of a steel brace system that is mounted within a column-beam frame. The commonly used friction damper systems are in the form of an X (friction damper being at the middle of the X) or a diagonal (friction damper being along the diagonal) inside a rectangular column-beam frame. Such a friction damper system is attached to the structural frame through connections at the column-beam joints.

Friction damper system's function is similar to that of a shock-absorbing system in a car. Earthquakes release energy through ground shaking motions, which induce seismic loads to a building structure. Friction dampers absorb the earthquake-induced energy (or load) when the steel plates slide against each other at pre-determined slip load, i.e. dissipating the earthquake-induced energy through friction-generated heat energy. Adding friction dampers to an existing building increase the seismic load carrying capacity of the building structure by means of reducing the demand of seismic resistance capacity upon the building's existing load carrying elements.

Friction damper system has been used in one federal building [Figure 1] and is currently being installed in a second federal building [Figure 2] in British Columbia. Use of friction damper system for a third federal building is under consideration.

To achieve cost savings while meeting equivalent seismic safety requirements, PWGSC decided to consider the use of friction dampers in this building. Evaluation of seismic performance using refined analysis confirmed that this technology would be suitable and cause minimum interruption to business operations. Both diagonal and X-braced friction dampers were used and staggered over the entire building. These friction dampers absorb the energy released/transferred from the earthquake through the ground to the building structure, thus reducing the load that the building structure would otherwise be subjected to during an earthquake. In this particular case, foundation upgrading was not required due to sufficient energy dissipation in the upper stories. [Figure 1](#) shows one of the X-braced friction dampers installed in the building.

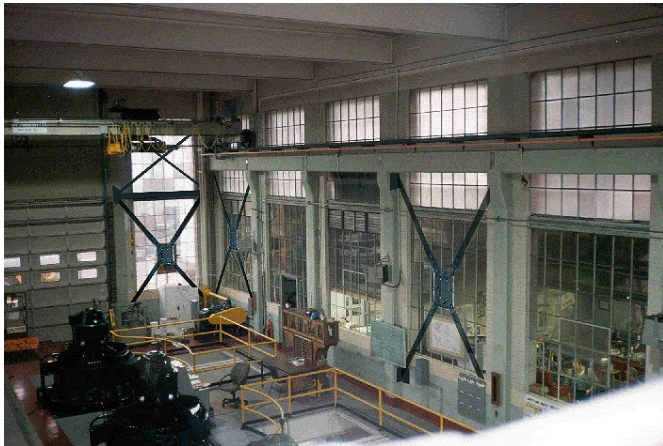
Figure 2 Pump House building: rendering of installation of friction dampers

Due to the two imposing conditions, the only practical solution appeared to be a combination of installing passive damping device such as friction dampers for the moment frame and wrapping the brick walls with CFRP sheets. The proposed non-intrusive solution for the structural framing of the main nave was accepted both by the heritage committee and by the facility's owner/operator. [Figure 2](#) shows a rendering of the main nave of the building with friction damper systems.

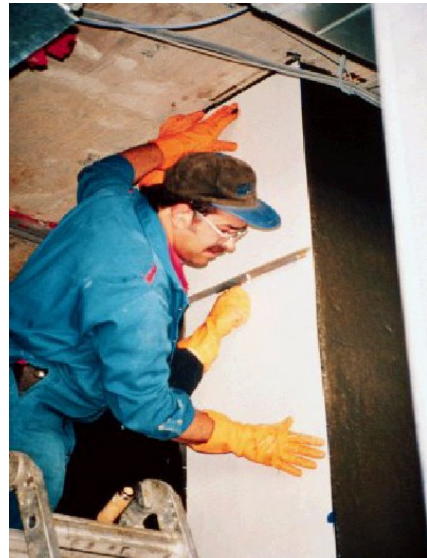
Figure 3 Port Alberni Building: CFRP application on a column

CFRP has been used on one federal building [Figure 3], is currently being used in a second federal building and will likely be used in a third federal building in British Columbia.

In order to meet equivalent performance and cost-effectiveness requirements, it was decided that the deficient columns be strengthened by means of wrapping the columns with CFRP. As the columns had adequate shear strength but were weak in flexural strength, the columns were wrapped full-height with one ply of CFRP. The Port Alberni Federal Building was the first application of CFRP for the seismic upgrade of reinforced concrete columns in western Canada. [Figure 3](#) illustrates the application of CFRP sheets onto the column. The structural upgrading cost was \$310,000 using innovative technologies.
